Marconi CM-11 Transmitter/Receiver Check-over, Testing and Refurbishment – Gerry O’Hara

Background

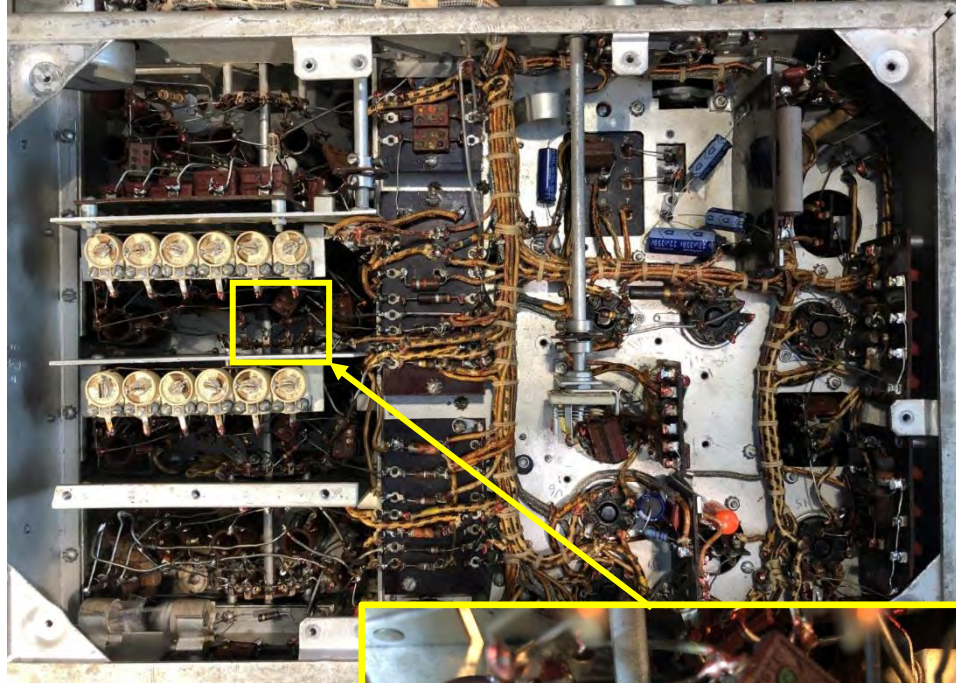
- two of the original tubular paper capacitors remained in place: these were the two 'primary shorting' capacitors in the RF amplifier stages (C19 and C32)² which short out the unused Band coil sections to ground. These two capacitors are very difficult to see, and even more difficult to replace, as they are buried deep in the RF amplifier

compartments (photos, above/right – the arrow on the insert enlargement points to one of these capacitors). They did, however, replace all the tubular paper capacitors hidden under and behind the various tagstrips. I decided to test the two remaining paper capacitors and attempt replacement if needed;

After testing the leakage on C19 and C32, ($\sim 10\mu\text{A}$ at 300v - not enough to cause problems, but probably better replaced), I decided to change-out these remaining two paper capacitors that someone either did not find when they did the re-cap, or gave up on replacing due to their inaccessibility. This was bit of a challenge – this job taking almost 2 hours as half of the band change switch shaft had to be withdrawn from the set (luckily there is a coupling on the shaft, otherwise the front panel would have had to be removed), and several bus wires to the coils and band change switch wafers needed to be temporarily removed to gain limited access and then repaired afterwards (photo, right – arrow points to a replaced capacitor).

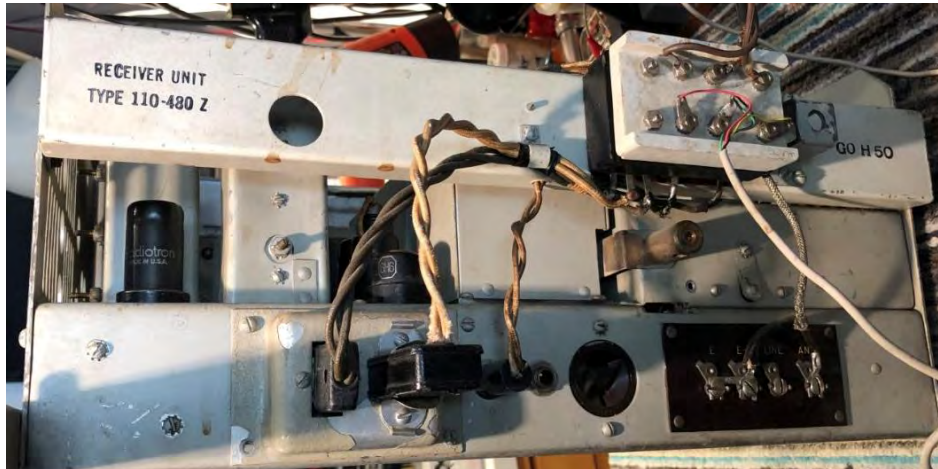
As I had connected the set to the speaker and power supplies through the rear 'snatch' connector (photo, left) I was driving an 8ohm speaker from one of these - that would explain the low output and distortion(!). Connecting the speaker to the low impedance 'phones socket on the

front panel gave much better audio, even with the low-emission 6F6 output tube.

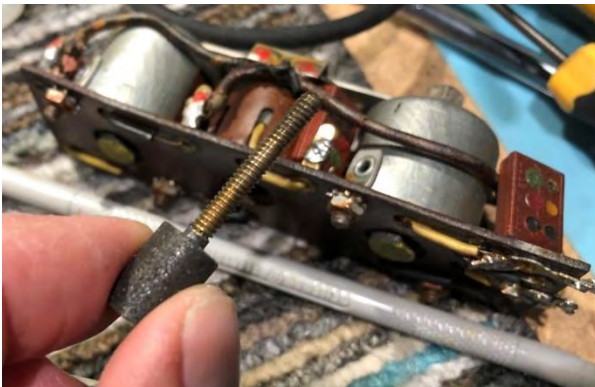
in the CSR-5 manual and found a fault that was traced to the 2nd IF transformer (T2). I suspected that the powdered iron slug on the middle coil in this transformer had detached from the adjustment screw (a fairly common issue with iron-cored IF transformers - I usually epoxy them back on without a problem). I removed T2 from the chassis, disassembled it and inspected all three slugs and adjustment screws – they were all in good condition and working ok (photo, left). I then disconnected

the silver mica (140pF) resonating capacitor on the middle coil - it also tested fine, so was re-installed. Also, all coils had continuity, so I re-installed T2 into the chassis and set up the IF again using the manual procedure and this time all three slugs on T2 adjusted perfectly. I can only conclude that there was a dry joint either on the middle coil, that was fixed by removing/replacing the resonating capacitor, or on the connections from T2 to the set, all of which were re-made during the removal/re-installation process (they did look a little suspect before removal). I then used a HP8600A/HP8601A sweep generator and digital marker generator combo to optimize the IF responses with/without the crystal in circuit. The photos, right, show the response curves for each of the four selectivity positions from position 1 (broadest response, crystal not in circuit) at top, to 4 (sharpest), bottom. No provision is made for adjusting the crystal phasing from the front panel, rather this is adjusted using a pre-set trimmer on the side of the crystal filter unit. The response plots show the IF is probably functioning as good as it gets and meeting spec.

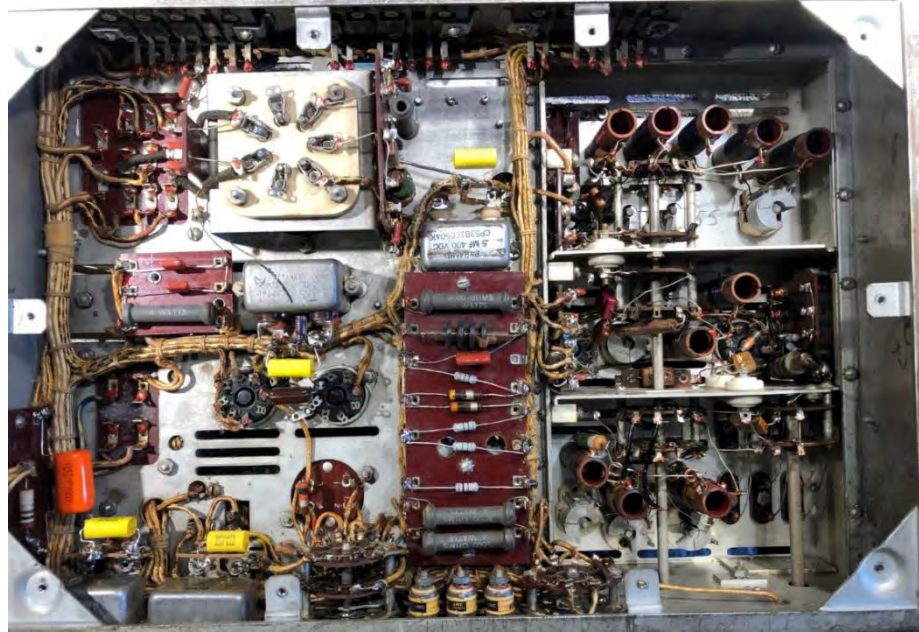
- all but one of the bathtub capacitors had measurable leakage current – nothing too serious (several 10's of uA at their working voltages), but this would eventually become worse with time and use. Also, the small replacement electrolytic had been wired across the old capacitor – not good practice. So, I decided to replace them all, using tagstrips mounted on the old capacitor terminals to

mount the replacement capacitors (all 630vV film types), and also re-wired the replacement electrolytic, a high quality 'Nichicon' part, to isolate it completely from the old capacitor (photo, above, which also shows several resistors that were eventually replaced – see 'Troubleshooting' below);

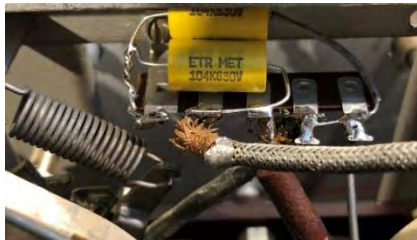
- The dual bathtub capacitor was leaking around 80uA on one section and 55uA on the other with 200vDC applied, so I removed it completely and installed two new 0.1uF 630vw plastic film types in its place mounted on a new tagstrip (photo, left);

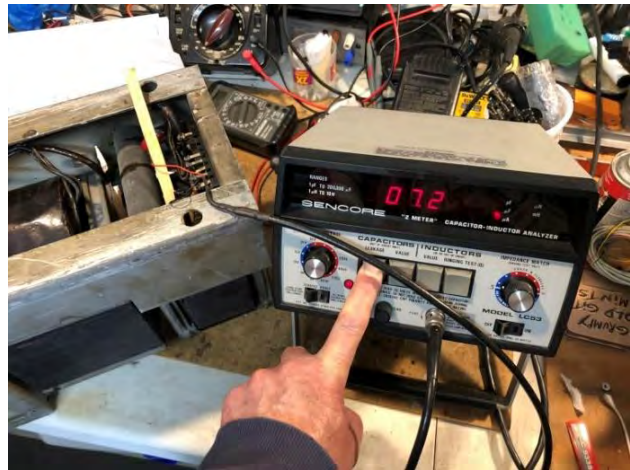
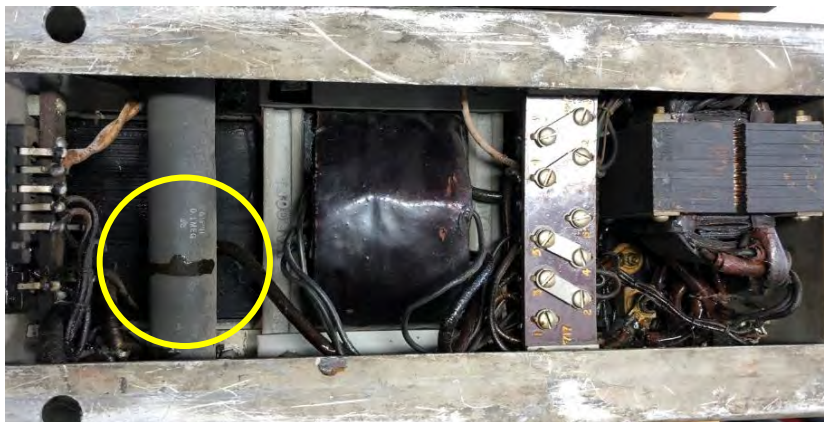
- I cleaned gobs of sticky insulation residue off the high wattage load resistor circled in the photo, below using acetone. This had been caused by poor lead dress that had draped wires around the resistor, which will get hot in use. I also tightened a loose (HT) connection to one end of this resistor. I then temporarily disconnected the opposite end of the resistor to check the 4uF 2Kv block paper capacitor: this measured 4.46uF with a leakage current of <8uA, but this was with only 600vDC applied using a Sencore LC53 capacitor tester (photo, above right) - the 'acid test' of this capacitor would be when it was powered up to >1300vDC.

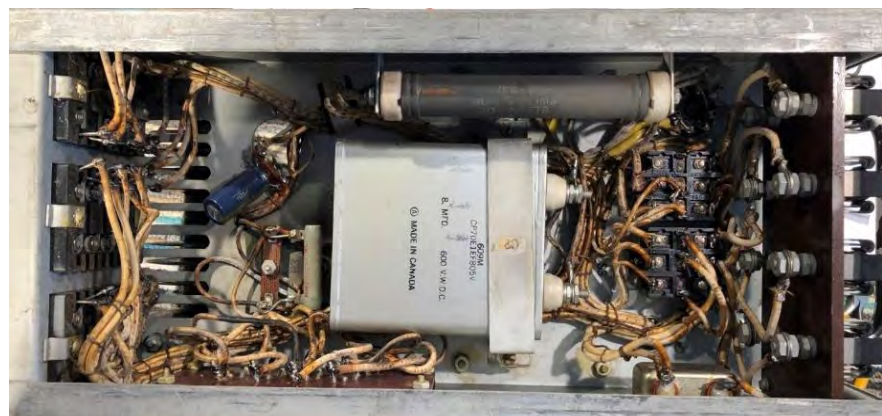
- The 8uF 600vw (block paper) filter capacitor (centre of photo, below) tested good (8.2uF, with <4uA leakage current at 500vDC using the Sencore LC-53);

- The 100uF 'hash filter' electrolytic capacitor had been replaced with a 1500uF 50vw

part (rather a high value, but should be ok);

- The rectifier tube was tested: I noted that a 5Y3 had been fitted, whereas the schematic specifies a 5Y4. These rectifier tube types have the same electrical characteristics but a different pinout, however, the tube socket wiring had been modified such that it will take either tube type. The tube tested low emission (55%) so I replaced it with a NOS one; and

- I temporarily disconnected the selenium full-wave low voltage rectifier stack (top of photo, right), and tested each section with an ohmmeter. This testing was inconclusive, so I fed 120vAC into the primary of the transformer feeding the rectifier and it output around 28vDC, so appeared to be working ok. This supply provides the 24vDC needed for the various relays used to control the system when operating the CM-11 on an AC supply.

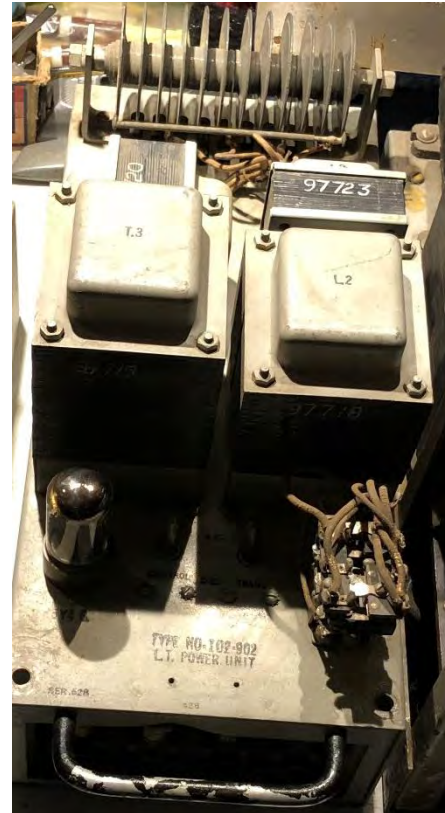
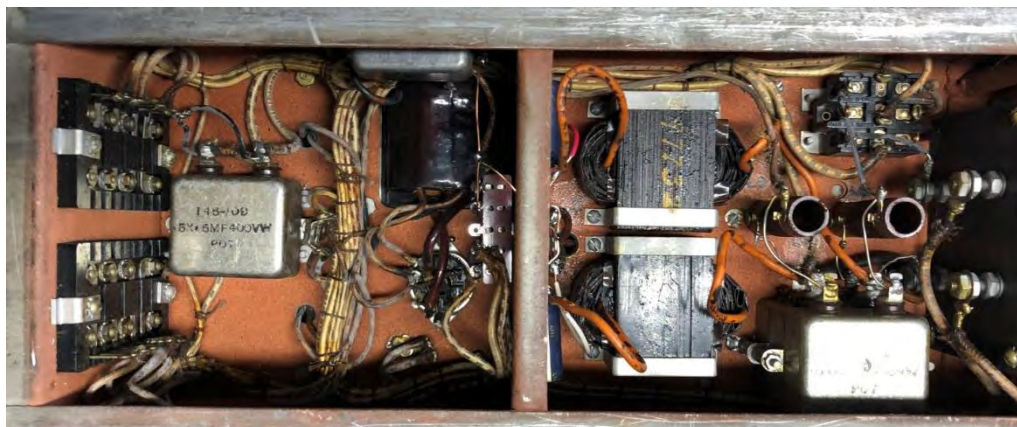
- The bathtub capacitors in this unit (photo, below) had not been replaced, however, they are all on low voltage circuits (tube heaters and the receiver supply 24v dynamotor as hash filters). Any minor leakage will therefore not affect the operation of the unit, so I left them all in place. Also, I checked

them in circuit and none appeared excessively leaky;

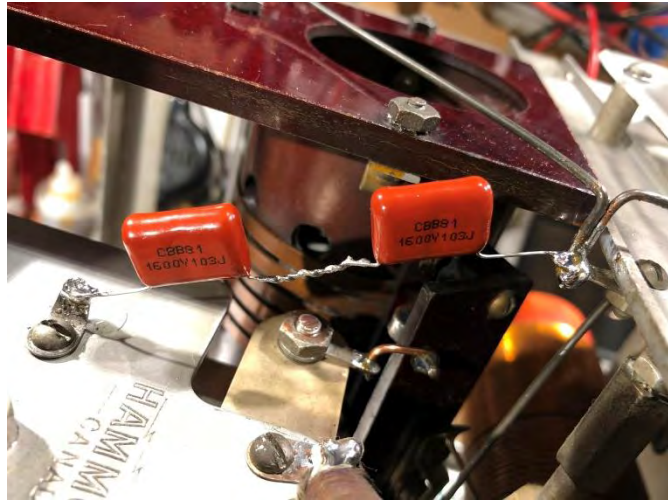
I subsequently removed the ATU from the CM-11 cabinet and changed out the 0.22uF 4Kvw capacitor for two 0.01uF 1600vw capacitors in series, photo, right, giving 0.005uF 3.2Kvw – the same capacitance value as shown in the schematic. I re-tried the CM-11 again, however, this time there was then another issue trying to power-up the transmitter (not the 'Man Aloft' key this time): I heard the HT delay relay click after around 15 seconds, but the remaining dial lights around the transmitter dial did not light up as they should, indicating the transmitter was ready for use. HT was not

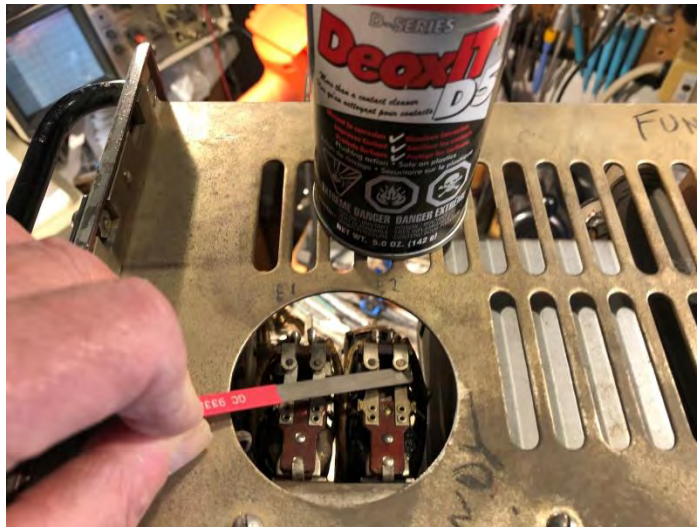
I suspected that dirty relay contacts had caused the switch-on issue this time, even though they had been lightly burnished and wiped with Deoxit-soaked paper (photo, left). So, I decided to take the transmitter chassis back up to the workshop and work on/test the relay action, clean the snatch

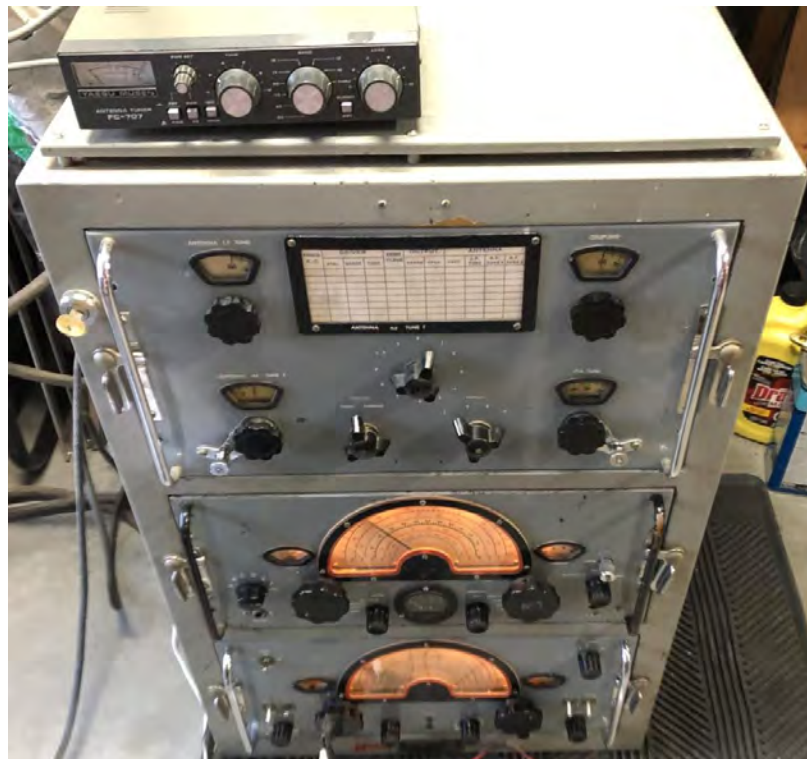
retried this several times and it worked correctly every time (nice blue glow in the 816 mercury rectifier tubes – photo, right), so, the intermittent switch-on problem was now resolved.

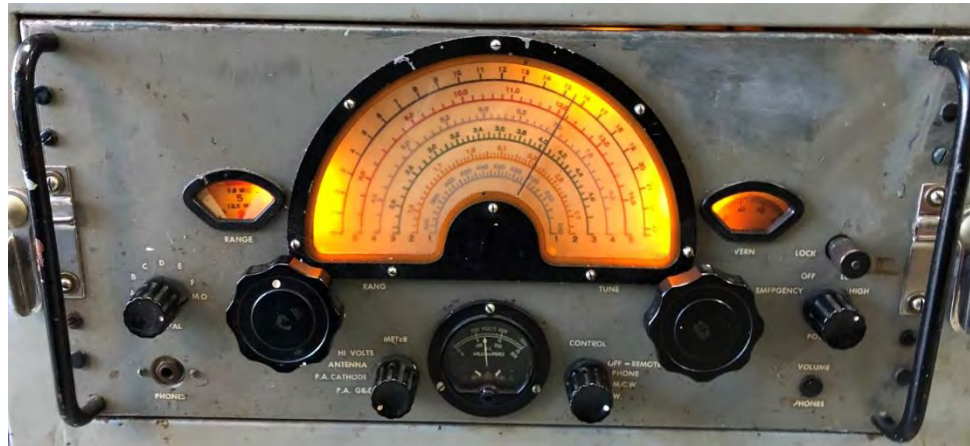
- I then replaced the tubes back into the 'spare' transmitter unit to try it out 'as-is'. This had also been worked on by someone, who had added some disc ceramic bypass capacitors to the PA stage and replaced some resistors, but all the tubular paper capacitors, as well as the 'bathtubs' were still in place;

- The 'spare' transmitter took a bit of coaxing to get working (likely dirty switch/relay contacts), but when it did power up (photo, right), it pushed out around 85W on 'CW', but again on 'MCW' and 'Phone' the indicated output power was significantly lower than spec. (around the same as for the transmitter I had been working on).

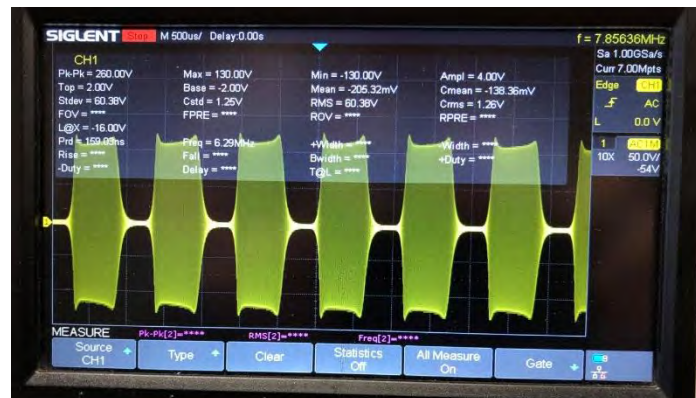
The 'scope trace on MCW showed the signal was over 100% modulated (photo, right), and there is no way of adjusting this in the transmitter. Over-modulation can cause harmonics, and I know the CM-11 has a reputation for generating these. Also, the complex waveform on MCW 'confused' the digital 'scope a bit – it was measuring the frequency as 7.8MHz and the peak to peak voltage measured by the 'scope's acquisition circuitry varied significantly, though the reported RMS voltage was steadier. This sort of waveform could certainly affect an analogue meter reading also (as in the Vanco unit). A video of some of the measurements being made using the 'scope can be viewed [here](#).
