Refurbishing a ‘Forgotten’ Marconi Atalanta Marine Receiver – Gerry O’Hara

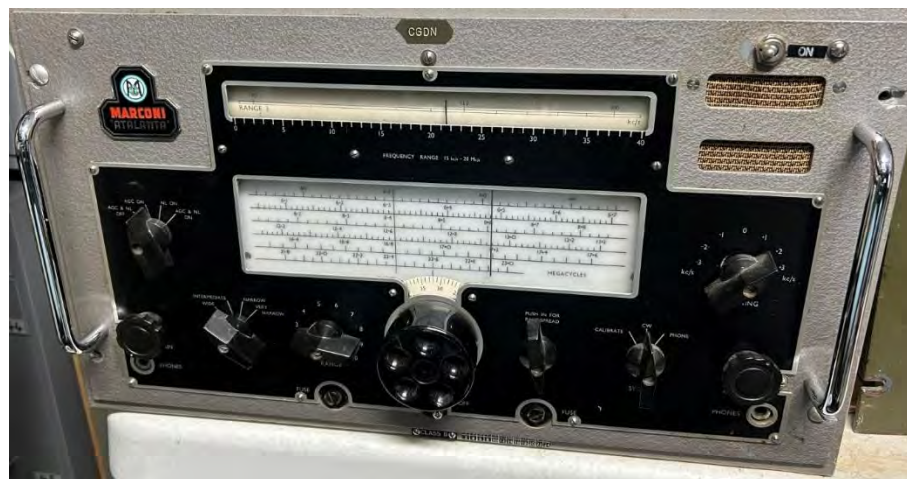
Atalanta receiver in his (very large) collection of communications receivers (photo, below) – it had become “buried under other stuff” over the years. He also mentioned that he had never used this one as it did not have an internal power supply², but after rediscovering it had decided that he would like to have it refurbished and an (external) power supply

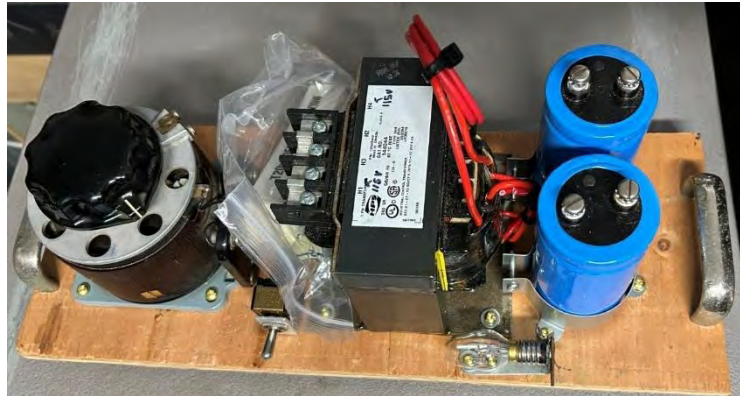
In a later 'phone conversation, my friend commented that he had some 'industrial' power transformers that had a 60vAC 5A secondary winding, and that he would like to use one of these with a voltage doubler rectifier arrangement to power the Atalanta – I suggested that if this was done, then a Variac should be included so that the output voltage could be adjusted to the required 110vDC. My friend subsequently partly constructed the power supply on a 'breadboard' (transformer, Variac, switch, fuseholder, capacitors and lamp) – photo, right, and provided this, plus the rectifiers, with the Atalanta.

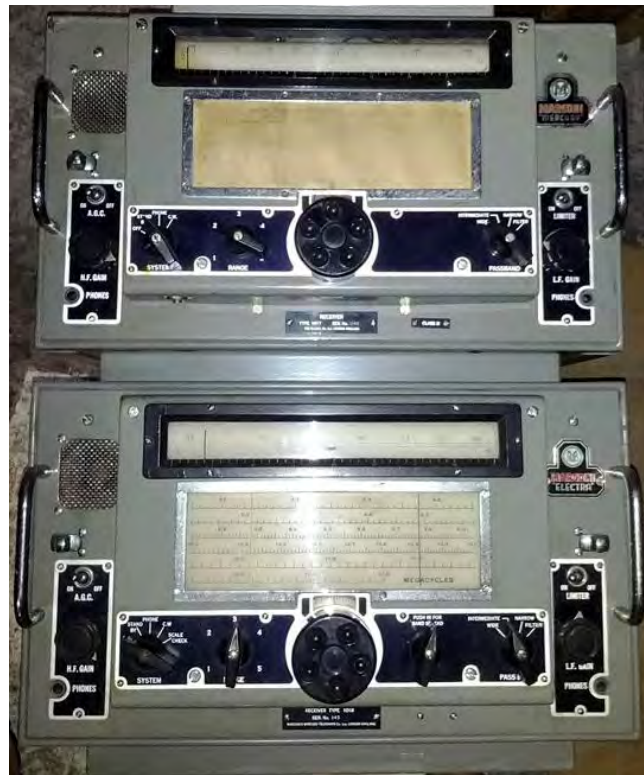
The (UK) Marconi company introduced two new receivers for the marine market in 1953 – the Model 1017 ('Mercury' – photo, right, top) and Model 1018 ('Electra'³ – photo, right, bottom). The Mercury covered 15KHz – 40KHz, and 100KHz – 4MHz, and the Electra covered 25KHz – 520KHz, and 1.5MHz – 25MHz, including a mechanical bandspread for the marine bands. The Mercury, with its limited frequency coverage, was designed specifically for the marine market, and was usually paired with the Electra on shipboard installations, as shown in the photo, right⁴, to increase the frequency range of the station to cover the HF marine bands. In 1958, Marconi introduced the similar-looking Model 2207C ('Atalanta' – photos, page 1), that provided a single main receiver solution for shipboard and marine shore station use, with continuous coverage from 15KHz – 28MHz, also with mechanical bandspread for six marine bands, combined with using more modern tube types and an overall improved technical specification. The Atalanta stayed in production until 1967⁵ and

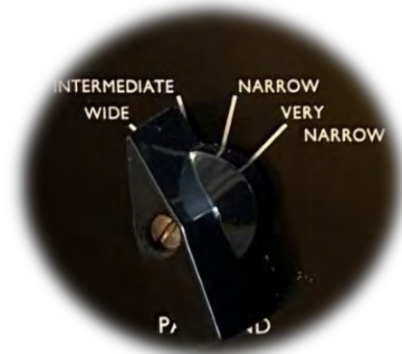
Four selectivity positions are provided: 'Wide' (8KHz), 'Intermediate' (3KHz), 'Narrow' (1KHz), and 'Very Narrow' (100Hz)¹⁸. The Wide, Intermediate and Narrow bandwidths are effected by varying the coupling between the primary and secondary windings of the 85KHz IF transformers. For the Very Narrow position, a 'magnetostrictive' filter is switched into circuit¹⁹.

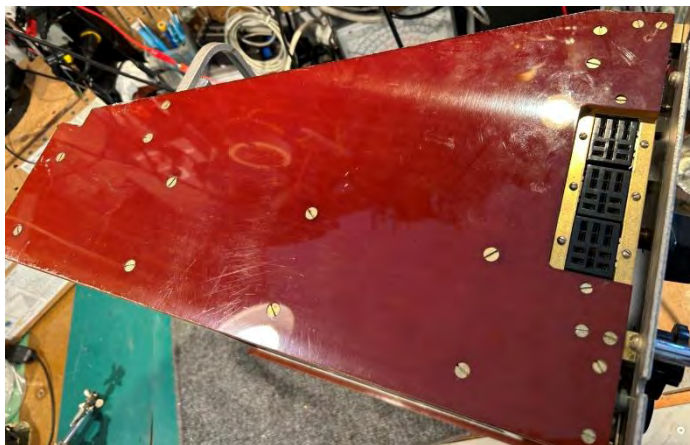
The Atalanta is built on a stout plated steel chassis, with even stouter phenolic ('Paxolin') side panels (photos, right and below). Being a 'live chassis' design, the insulated side panels and other provisions for insulating the cabinet and front panel/controls and 'phones jacks is necessary for safety, and a prominent 'DANGER. LIVE CHASSIS' notice is attached to the rear of the front panel as a warning to anyone removing the chassis from the cabinet²².

The RF deck is located on the right, and IF/audio circuits on the left (viewed from the front).

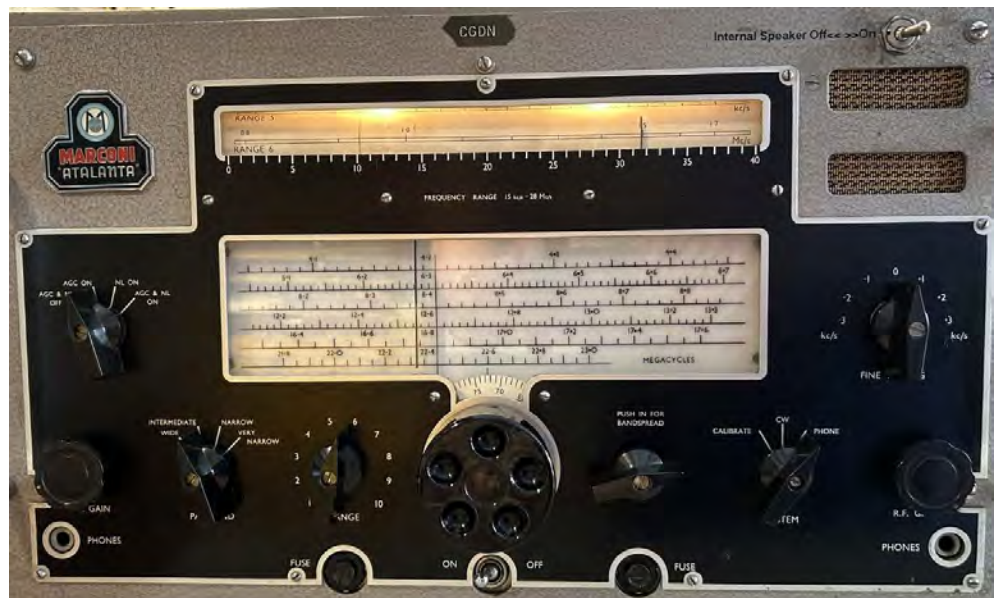
The front panel controls (photo, right), comprise AGC/Noise Limiter, AF Gain, Passband (selectivity), Range (band), Tuning, Bandspread Tuning (labelled "Push in for Bandspread"), System (mode/function), RF Gain, Fine Tuning, and Mains On/Off (toggle). Two ('mains') fuses

and two 'phones sockets are also provided on the front panel. Many Atalanta receivers, including this one, were fitted with a small internal speaker and a toggle switch to mute this when an external speaker/'phones were used. The main tuning dial is a rotating drum with a movable pointer. A logging

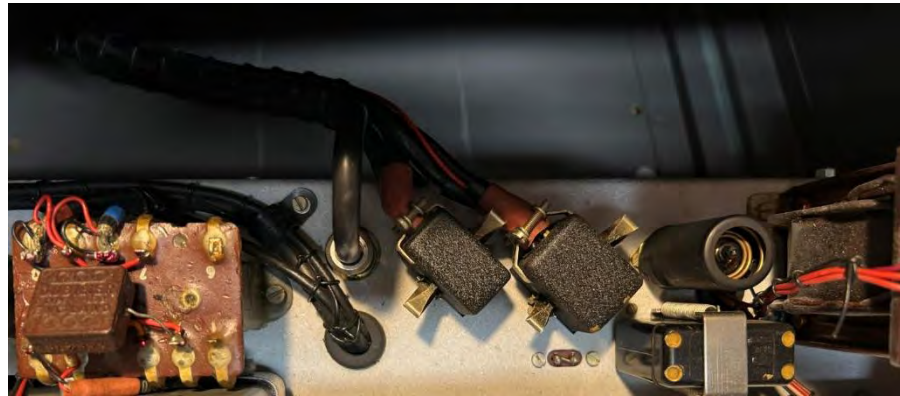
There are no controls or other facilities on the rear of the receiver, and connections to the power supply and any connections to a transmitter, eg. for desensitizing, are via flying leads that enter the cabinet through a louvre at the base of the rear of the cabinet. The antenna connection is via a 'Belling-Lee' socket mounted on the right side of the cabinet. The 'mains' filter and terminal blocks to connect to receiver circuits are mounted on the inside of the rear cabinet panel, these connecting to the chassis via two umbilical cables fitted

with Jones plugs (photo, right). The umbilical cables and the coax cable are sufficiently long to allow the chassis to be connected outside the cabinet for servicing. The 'Belling-Lee' antenna socket connects to the receiver via a coax cable

fitted with a 'Belling-Lee' plug at the receiver end, this mating with a second 'Belling-Lee' socket on the chassis (to the left of the Jones plugs in the photo, above), the shield of the coax cable being isolated from the ('live') chassis at DC, but coupled at RF via a capacitor.

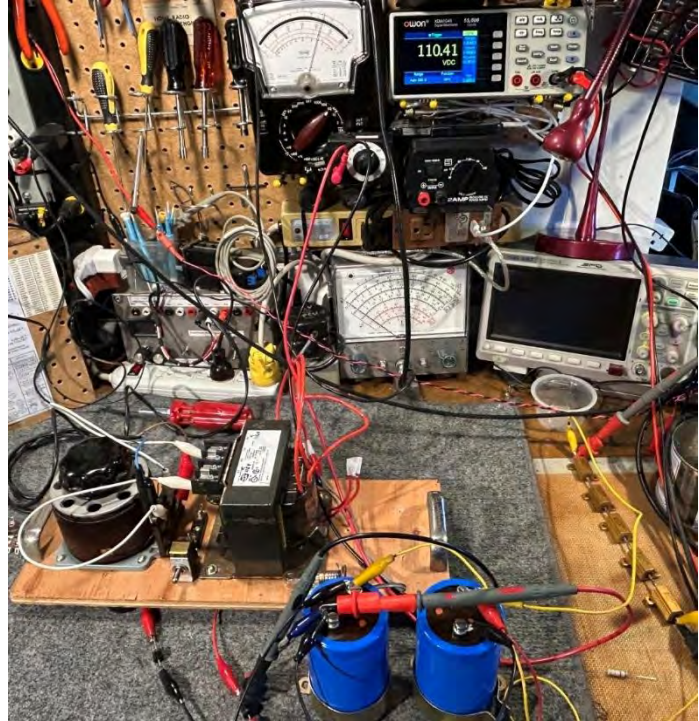
Next, I tested the circuit with a 10Kohm 2W resistor as the load - all seemed to work ok, so I strung together five metal-clad 50ohm 25W resistors in series to provide a 250ohm 125W load (though without being bolted to a heatsink, probably more like 60W) – these resistors can be seen at the right side of the photo, right. This would draw around 440mA - a reasonable representation of the current draw of the Atalanta receiver (300mA heater string plus an estimated around 130mA B+ current draw).

I found that an input voltage of around 45vAC to the voltage doubler gave an output voltage of 110vDC with the 440mA load connected. I left this arrangement running for around twenty minutes and took some thermal images - the power supply components were all running fairly cool, but

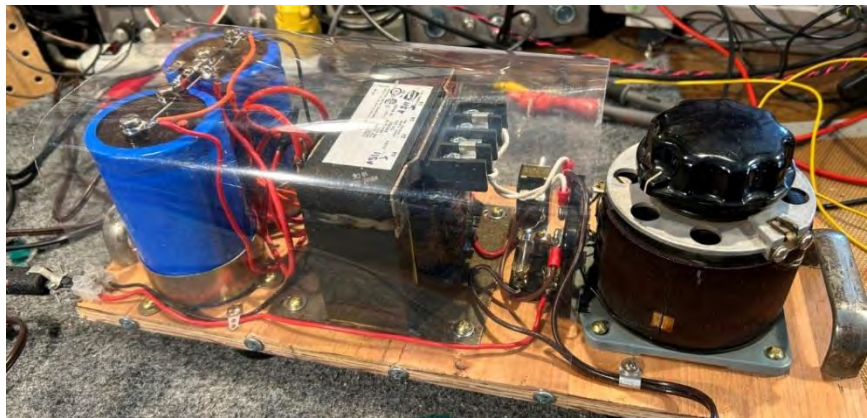
over the high voltage parts of the power supply (photo, right) - a bit crude, but did the job, at least as a temporary measure. The on-off switch could be operated by curling a finger around the end of the guard, though the guard would need to be lifted off to change a fuse (four screws and it lifts away). I

also added a connection block to the output, and wired-in a 2-pin in-line Jones socket on a short 'pigtail' wire ready for when it was time to test it with the receiver.

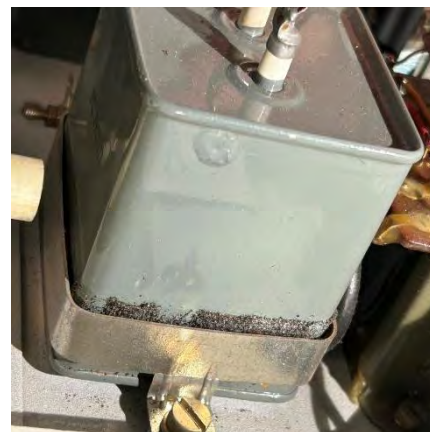
Above the chassis, all looked to be in good shape (photo, page 6), however, I noted that the 8uF metal clad paper 'block' B+ smoothing capacitor was a little loose in its clamp, as the layer of foam between the capacitor and the clamp was degrading to dust (photo, right), however, this was not of great concern.

On first glance, none of the 'TTC' manufactured tubular 'Metalmite' metal-clad paper capacitors or electrolytic capacitor seals underneath the chassis (photo, above) appeared to be cracked or seeping fluid, so that was good sign... so, given my experience with these chassis in the past, I asked the owner if he would like me to try powering it up after

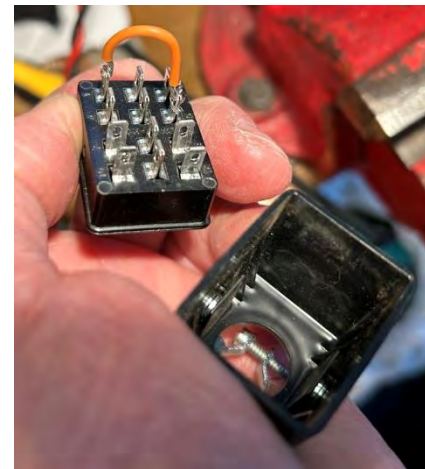
After some thought and checking the schematic (page 12 and Appendix), I resolved the non-working speaker problem - there were actually two problems: the first was that two of the terminal block connections in the cabinet ('13' and '14') must be connected together for the internal speaker to be connected - without the cabinet, of course these were not(!). These terminals correspond to pins 1 and 6 of the 12-pin chassis-mounted Jones plug. I found a 12-pin socket in my junk box, connected pins 1 and 6 (photo, right), installed it on the chassis socket (photo, below), and.... still

silence(!). The second issue was tarnished contacts in the switching 'phones sockets - these needed burnishing and cleaning with Deoxit D5. After that, the internal speaker was finally working. A short video demo of the receiver working at this stage can be viewed [here](#).

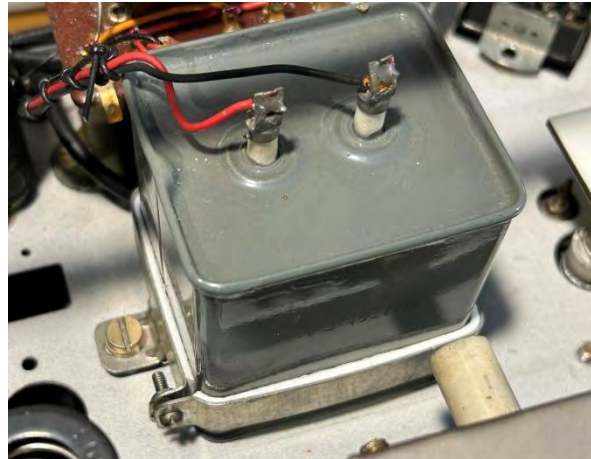
At this stage, the 8uF block paper B+ filter capacitor was starting to annoy me: as I moved the chassis about, pieces of the foam were falling on the bench, and the capacitor was becoming looser as result. So, I removed the capacitor (and clamp) from the chassis, scraped the remaining foam off the capacitor body and the clamp, placed some new adhesive foam strip around the inside of the clamp and re-installed the capacitor onto the chassis (photo, right) – now solid as a rock.

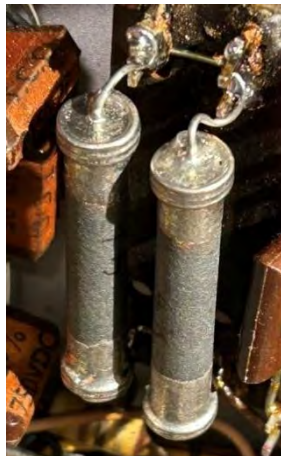
These thermistors are a little larger physically than the CZ2, but have a similar characteristic resistance v. current curve, and a higher maximum instantaneous surge current. At 125mA, their resistance is quoted at around 110ohms. With two of these in parallel with the 330ohm power resistor, this would give a 14v drop. Subtracting this from the 110vDC supply voltage, and allowing around 8v for loss across the two 4v dial lights (in series) and the Brimar 'CZ9' thermistor in parallel with them, would result in around 88v at the 'hot' end of the tube heater string (the manual specifies this as 88.6v +/-10%). Note: thermistor characteristics are, in my experience, not 'exact', so some leeway could be expected in these calculations in practice.

So, I decided to try two CZ1 thermistors (photo, left), in place of the two 270ohm resistors that someone had replaced the original CZ2 thermistors with.

The result was a longer warm-up time - around 1.25mins for audio to appear (as expected) - with around 55v at the 'hot' end of the heater string, less bright switch-on dial light glow, and a voltage of 86.5v at the 'hot' end of the heater string when fully warmed-up (I found this voltage reached around 84v within a couple of minutes, then slowly crept up to 86.5v over the next 5 minutes or so). I checked a few individual heater voltages and these were now much closer to the 6.3v and 13v needed.

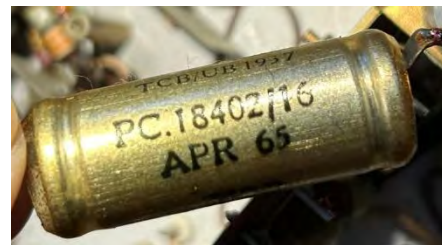
I initially replaced the two tubular electrolytics, six of the metal clad tubular paper capacitors, and 18 resistors. The electrolytics I removed had both failed – the 50uF output stage cathode bypass capacitor, dated April, 1965 (photo, right), measured 140uF with almost 2mA leakage (photos, below), and the 20uF 1st AF stage cathode bypass capacitor had no measurable capacitance and 4.3mA leakage at half its rated working voltage. All the paper capacitors replaced were close to their nominal values but were leaky. I checked most of the resistors, and they were all within tolerance apart from the ones I changed. None

were too far out of tolerance – the worst was around 20% off its nominal value. There were several resistors I had not yet checked, but planned to do so later. I suspected that most of the remaining tubular paper capacitors in the chassis were probably leaky also. I checked a few at random, and all leaked between around 2uA and 8uA at 100vDC. There were around another 26 in total, mostly 0.1uF parts. I recommended to the owner that they should probably all be replaced during the refurbishment and he agreed.

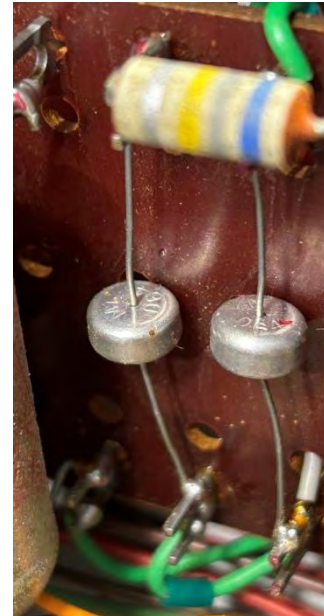
Preliminary investigation identified that one small signal selenium rectifier was open circuit ('MR1' – the left hand one in photo, right), and that explained the lack of AGC being applied to the RF stages as this rectifier (part of the de-sensitizing circuit) is in that AGC line. The other three readily accessible small signal selenium rectifiers measured very high resistances (megohms). Two of these were in the noise limiter circuit ('MR3' and 'MR4'), and one in the desensitize circuit ('MR2'), though none of these having a high resistance should affect the AGC operation. The two small signal selenium rectifiers that actually generate the AGC voltage from the 85KHz IF signal ('MR5' and 'MR6'), are located in the 'Noise Limiter and AGC Assembly' ('AGC Assembly'), which resembles the IF transformer cans. Access to these and their associated components (several resistors and capacitors) necessitates removal of the AGC Assembly containing them from the chassis.

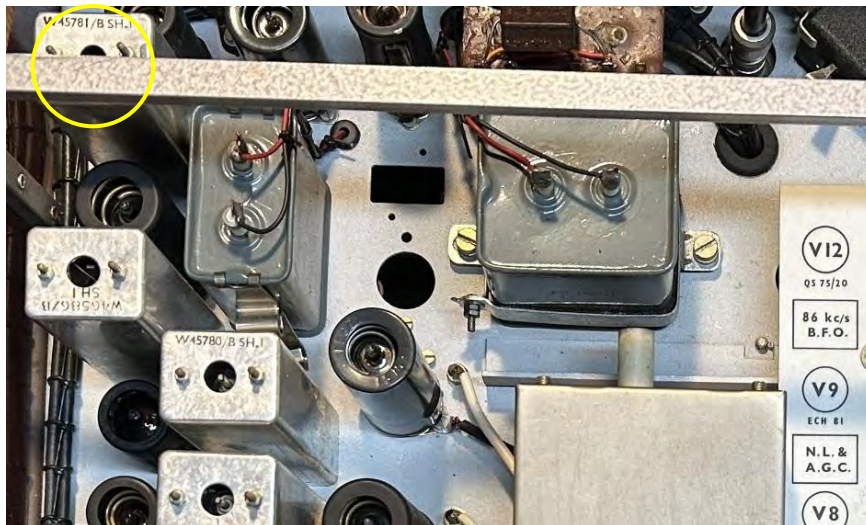
Prior to removing the AGC Assembly from the chassis (circled in photo, left), I was able to do a rough test of 'MR5' (providing delayed AGC to the two RF stages) by measuring resistances between terminals on the AGC Assembly, and 'MR6' (providing both AGC to the 1st IF stage, and a bias voltage for the noise limiter circuit), without removing the

can from the chassis. 'MR5' appeared to be rectifying (also confirmed by some RF stage AGC is being produced, but not delivered due to failure of MR1), but had a high internal forward resistance (around 220Kohms), but not as high as 'MR3' and 'MR4', these measuring around 2Mohms to 4Mohms respectively. This rough test also indicated that 'MR6' could be shorted if an associated 0.1uF capacitor to ground was not leaking badly, or high resistance in both directions if that capacitor was very leaky. However, I really needed to remove and open up the AGC Assembly and check/replace parts as needed. I did change out the accessible AGC smoothing/time constant capacitors (both were leaky), but another two 0.1uF capacitors were lurking inside the AGC Assembly, including the one associated with 'MR6'.

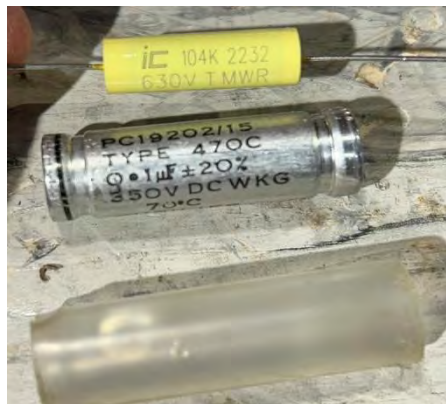
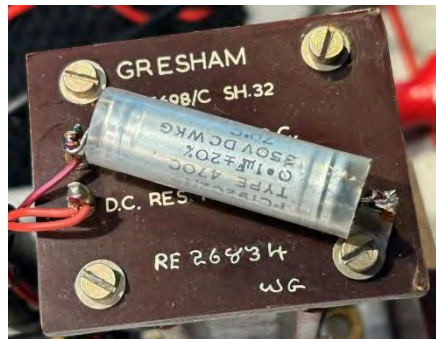
by the set's owner. I left the large 2uF tubular paper capacitor located under the two relays near the rear apron in place, as it was going to be a very fiddly job to remove it (removing the relays, etc.), risking damage to some of these parts. So instead, I disconnected one end of this capacitor (the other end is grounded to chassis), and installed a new

capacitor between the relays and the antenna section compartment divider. This 2uF part is a 'yellow jacket', but I put some black heat shrink around it so it did not stand out visually (tip of arrow in photo, below right). For the metal-clad

tubular paper capacitor mounted on the top of the B+ filter choke, as this is located above the chassis, I re-stuffed the original capacitor (three photos, left), so the top of the chassis looked all-original.

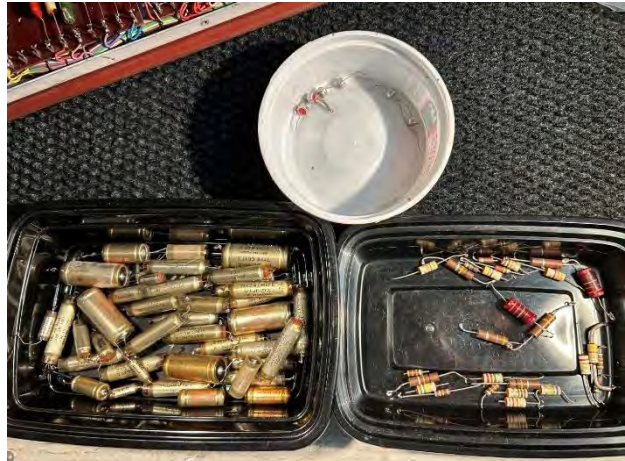
I tested some of the removed parts: all the tubular paper capacitors were leaky, with one (in the AGC/Noise Limiter can) leaking almost 2mA at 100v, with some of the others in the 20 –

50uA range, so all were ready to be changed out. The resistors I removed from within the two cans were mostly out of tolerance – but not greatly, up to around 20% or so. I also made some measurements on the Brimar M1 selenium diodes after they were removed from the chassis. The results are included in the Appendix. By this stage, I had replaced a total of 39 tubular paper capacitors, 2 tubular electrolytics, 27 resistors, and 6 selenium diodes (removed parts shown in photo, right).

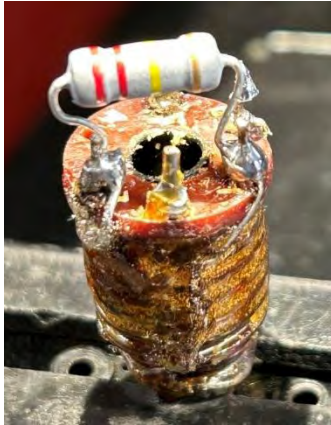
I removed the Band 6 antenna transformer (L7) and, after some very careful probing and scraping away at the hard cement they used to seal this coil with, found that the end of the secondary winding had come away from pin 3 on the coil former. The wire used for that winding is not Litz, but very fine enamel-coated stranded wire. I teased-out as much of the end of the winding as I could (of course it was the end that vanishes into the inside of the coil), scraped the enamel off, added some liquid flux, managed to tin the wire strands, then checked the winding continuity – this checked ok. I then wrapped and soldered a short piece of wire to the top of pin 3 on the former, bent it down over the windings and

soldered the end of the secondary winding to it (circled in photo, above right).

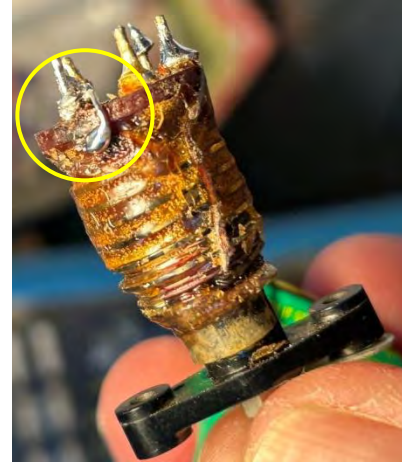
I also installed a new 220Kohm damping resistor across the secondary winding (between pins 1 and 3) – photo, left. The secondary winding resistance measured 2.92ohms, which was around the value I had estimated based on the Band 5 and Band 7 secondary resistances (8ohm and 0.9ohm respectively – see Appendix). Judging by soldering iron 'scars' on the insulation of several pieces of nearby connecting wires, and a missing washer from one of the mounting screws on the coil former base, someone had already had this transformer out of the chassis – probably tried to see if they could fix it, gave up, and reinstalled it.

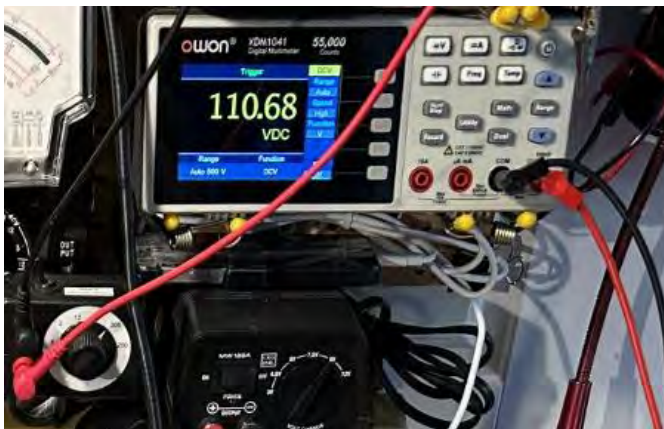
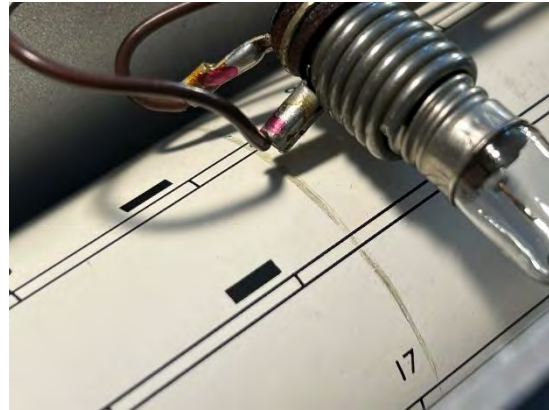
present at approx. 370KHz intervals on the HF bands – this needed investigating (possibly an artefact, eg. beat with a local station, due to incorrect adjustment of an IF trap?). The spurs were at a low level, and manifested more of a 'bubbling' noise rather than a pure carrier signal, which made me think it was either a local station beating with an oscillator in the set, eg. the 615KHz 2nd local oscillator, or a parasitic of some sort. A video demonstrating these apparent spurs can be viewed [here](#).

However, after further investigation, I found that the 'spurs' were not spurs at all, but RFI from my OWON bench DMM! (photo, left). I had been using this handy DMM to keep an eye on the voltage being fed to the Atalanta from the home brew power supply, so it was always switched on when the receiver was operating. However, after a session checking various bands for the spurs, I happened to switch the OWON DMM off while the receiver was tuned to one of the spurs (on 19.966MHz, which was one of the stronger

ones), and the spur vanished. I tuned around the bands, and the spurs had all gone. I switched the OWON DMM back on and they all reappeared! I did a double check with a couple of small solid-state receivers – one tuned to 19.966MHz, and the other to 370KHz, and they picked up the same RFI – see video [here](#). Strangely, the Atalanta was receiving the interference from the OWON DMM with or without an antenna connected, likely because the chassis base plate was absent, and/or, the RF trimmers are all exposed above the chassis. So, placing the receiver into its cabinet should solve any similar issues in the future.

I realized that had forgotten to install the two small screening plates over the base of the RF tube sockets, so I installed those – doing this seemed to weaken the spurs, but they were still present.

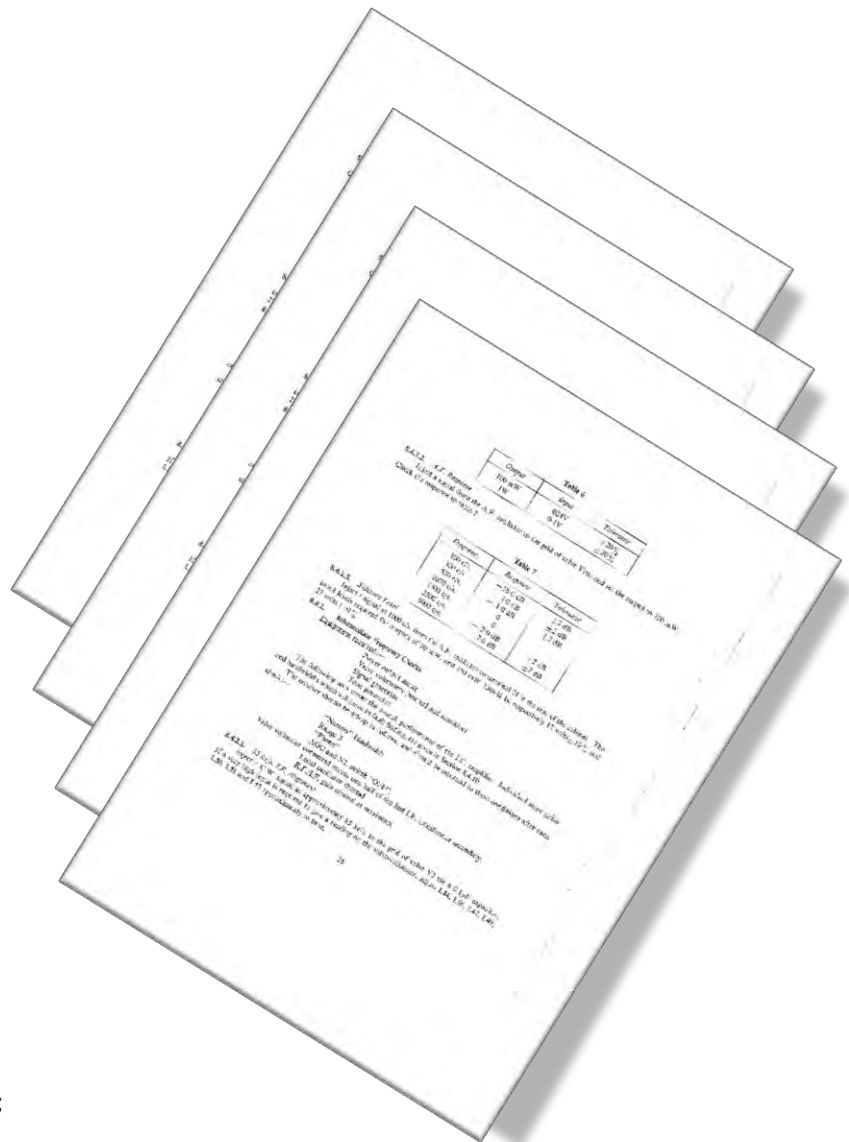
- Noise output check*;
- Image and IF rejection checks*;
- Signal to noise ratio checks**;
- Overall AGC checks;
- Improvement of signal to noise ratio*; and

- CW limiting and stability checks*.

I skipped over (or partially skipped over) a few of the above steps (marked with an asterisk), as although the check described can be carried out, if the receiver does not comply, there is not much that can be readily done about it - only if there was a significant underperformance would further investigation as to the cause be needed. I also abbreviated some of the steps (two asterisks), where extensive checking of

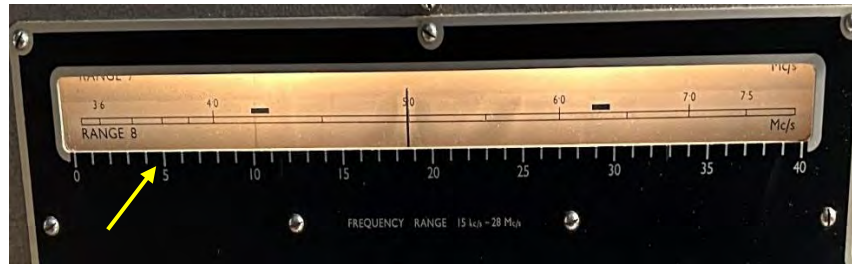
The RF section tracking points for each band is given as a point on the main dial logging scale (tip of arrow on the photo, below right), rather than at specific frequencies, so I identified a frequency close to the logging scale points noted and used these for the RF alignment, these being:

Band	Bottom	Top
1	16KHz	25KHz
2	30KHz	100KHz
3	100KHz	200KHz
4	200KHz	400KHz
5	420KHz	800KHz
6	850KHz	1.7MHz
7	1.8MHz	3.5MHz
8	3.7MHz	7.5MHz
9	8.0MHz	15.0MHz
10	16.0MHz	27.0MHz

These seemed to work well, with good tracking obtained on all bands. Most of the IF and RF trimmers and slugs were close to their optimal positions, with the most adjustment being needed on the 3rd 85KHz IF transformer, the BFO, 2nd local oscillator (615KHz), the 1st local oscillator on Band 6, 8, 9 and 10, and a few of the RF amplifier stages.

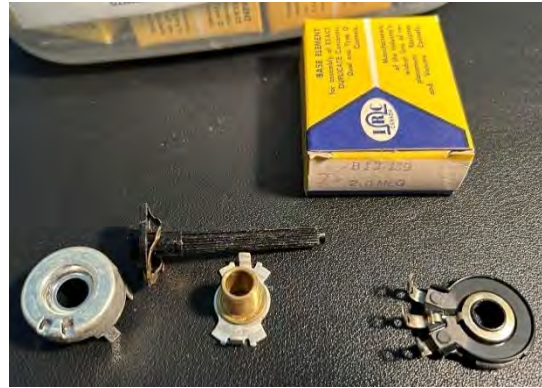
had ignored the issue at that time. So, after completing the alignment, I removed the knobs and front panel and replaced this pot. This is a 2Mohm log-taper part, and had been replaced previously with ('Made in USA') linear-taper part, so no wonder the volume could not be adjusted easily at the low end of its travel. I did not have a 2Mohm log-taper pot in stock, but found the required components to make one in a NOS 'IRC' pot kit (photo, right). While the front panel was removed from the chassis (photo, below), I cleaned the rear of the main and bandspread dial covers with anti-static

cleaner, and cleaned all the knobs and fingerplates before refitting the front panel and knobs to the chassis.

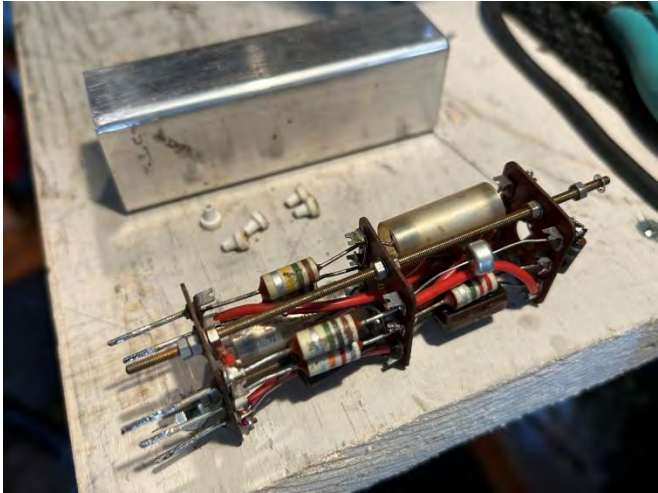
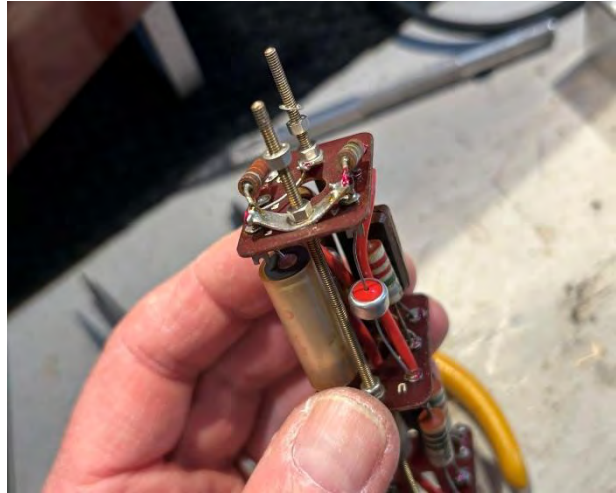
Above top left/right: disassembled 'AGC Assembly' – note the small signal selenium diodes

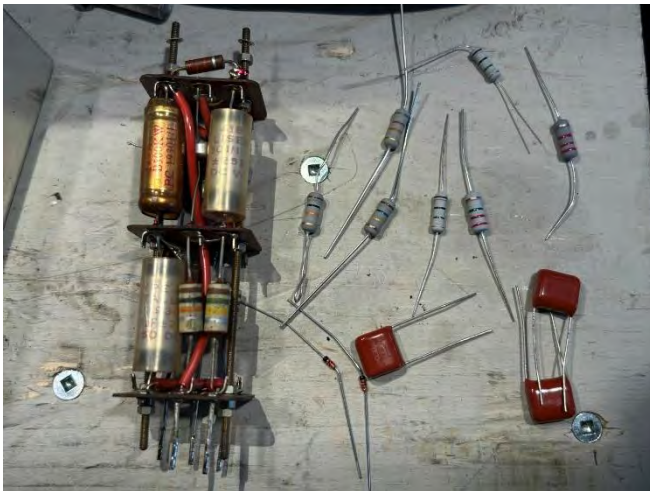
Above: assembling the parts needed to replace the components in the 'AGC Assembly' (I subsequently decided to use axial lead capacitors as these suited the layout better)

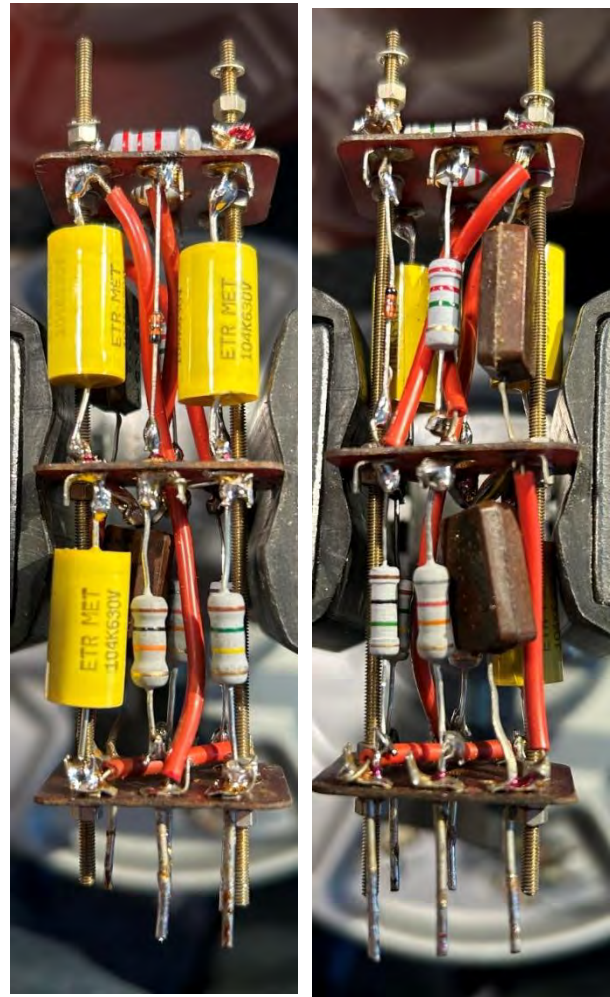
Above: two views of the reconstructed 'AGC Assembly'. Left: the circuit of the 'AGC Assembly' was first reconstructed on a breadboard to experiment with diode types and series resistors

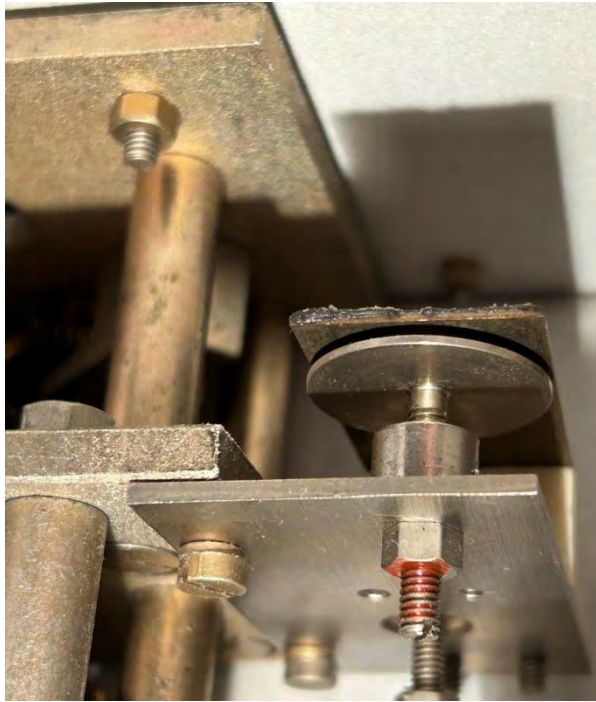
Above: the rear of the tuning gang cover looks like it should be attached to the end plate of the tuning gang – but its not(!). Left: the adjustable air-spaced temperature compensation capacitor across the 1st local oscillator section of the tuning gang. Below: the (above chassis) RF deck trimmers and slug adjuster screws – a 'twiddlers delight'...

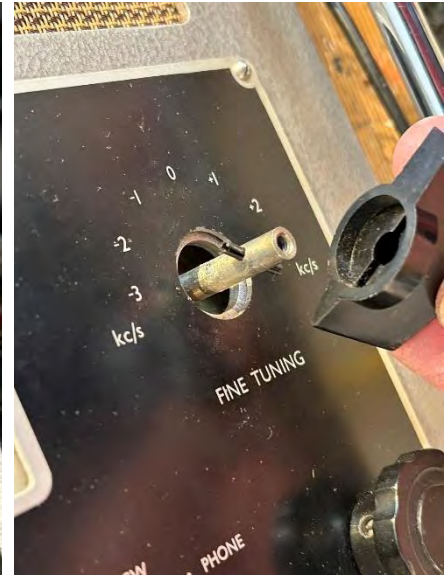
Above left: the cover for the RF deck provides a lot of useful location information. Above: all of the knobs, except the AF and RF gain controls, are screwed and keyed onto their shafts. Below left: view inside the cabinet after wiring-in the 110vDC line and filter ground wire. Below: the static discharge resistor across the antenna socket

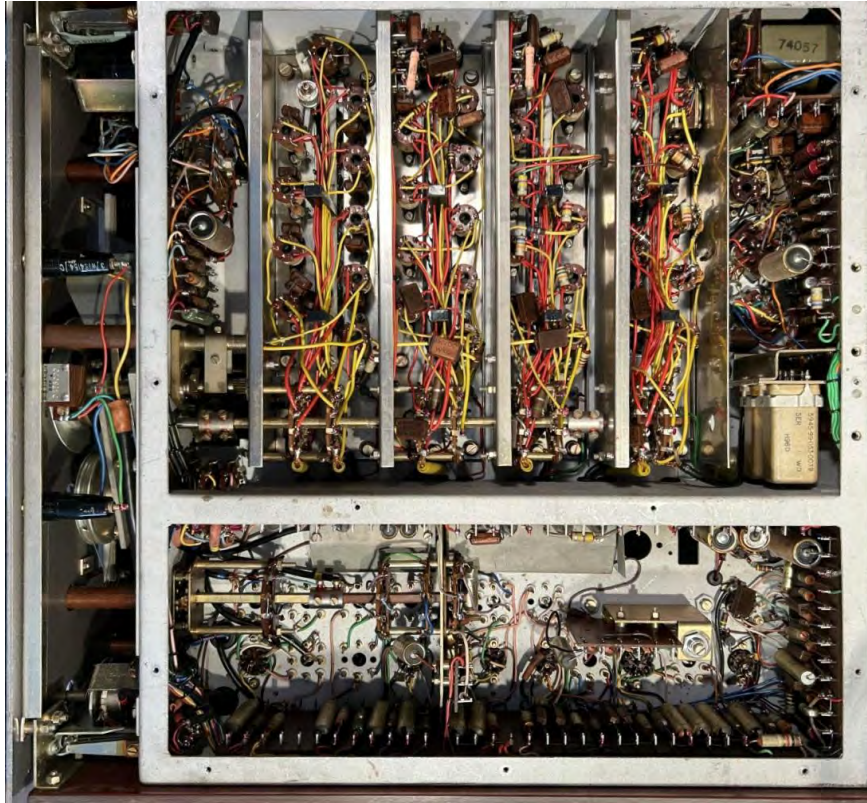
Left: underside of the chassis prior to component replacement.

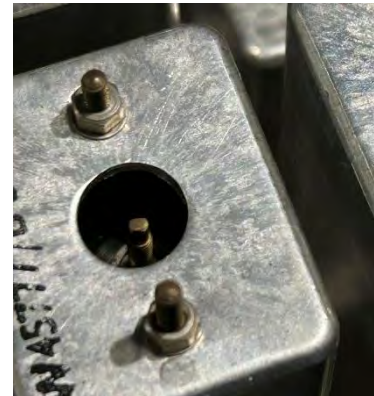
Below: close-up of the adjustment screw in one of the IF transformers (similar ones used in the RF deck) – very easily damaged if the incorrect tool is used

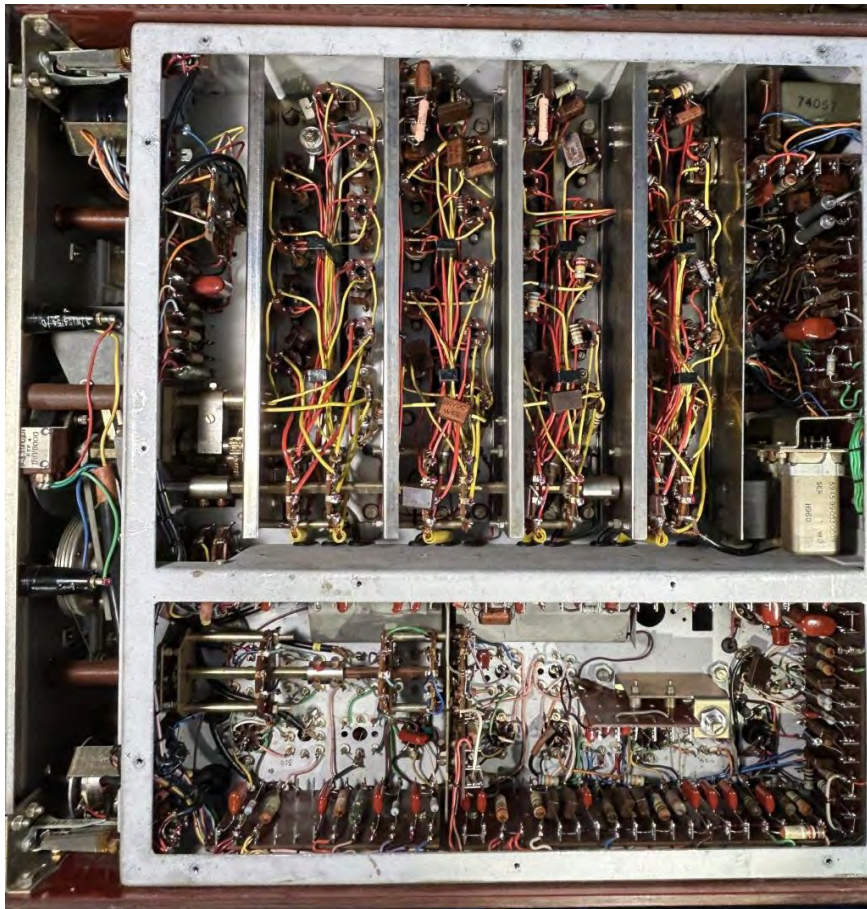
Right: underside of the chassis after component replacement.

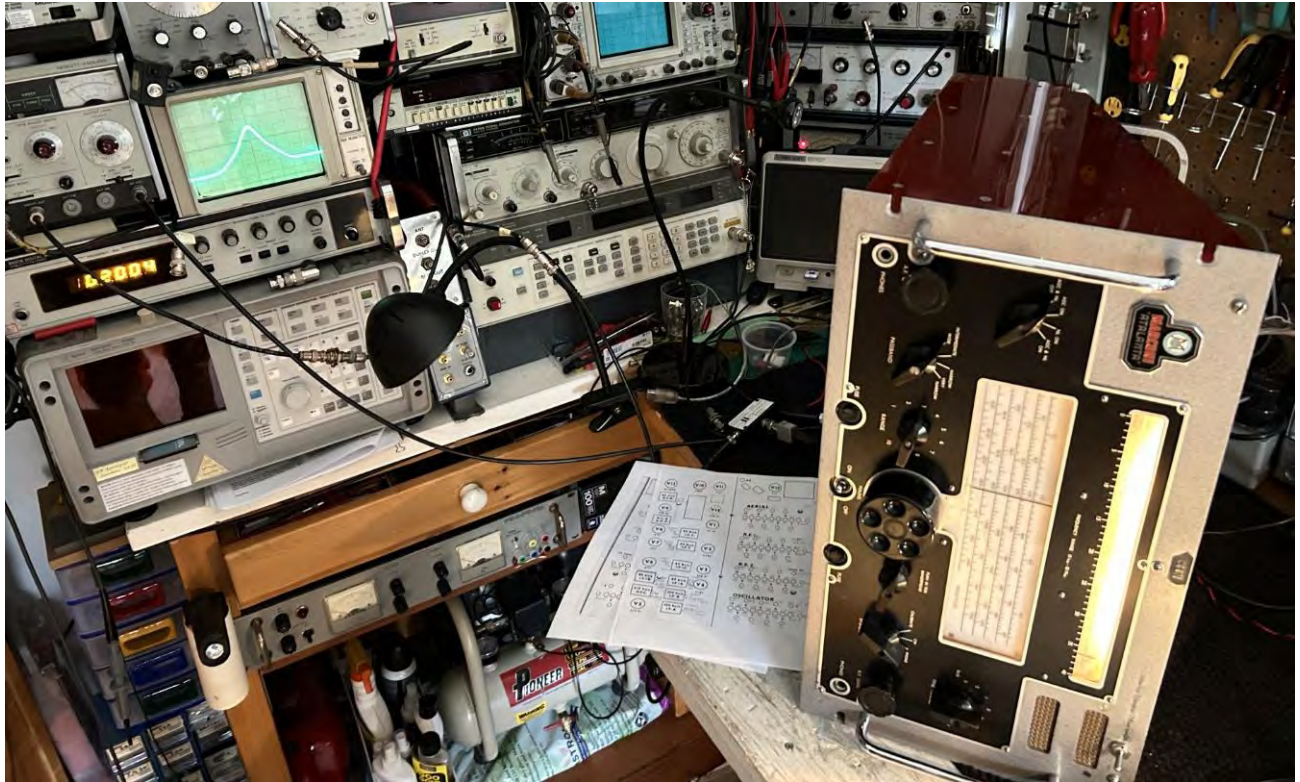
Above: checking the shape of the 85KHz IF response curves using an HP8601A/HP8600A sweeper/markers generator, displayed on a Tektronix 604 monitor (upper left quadrant of this photo)

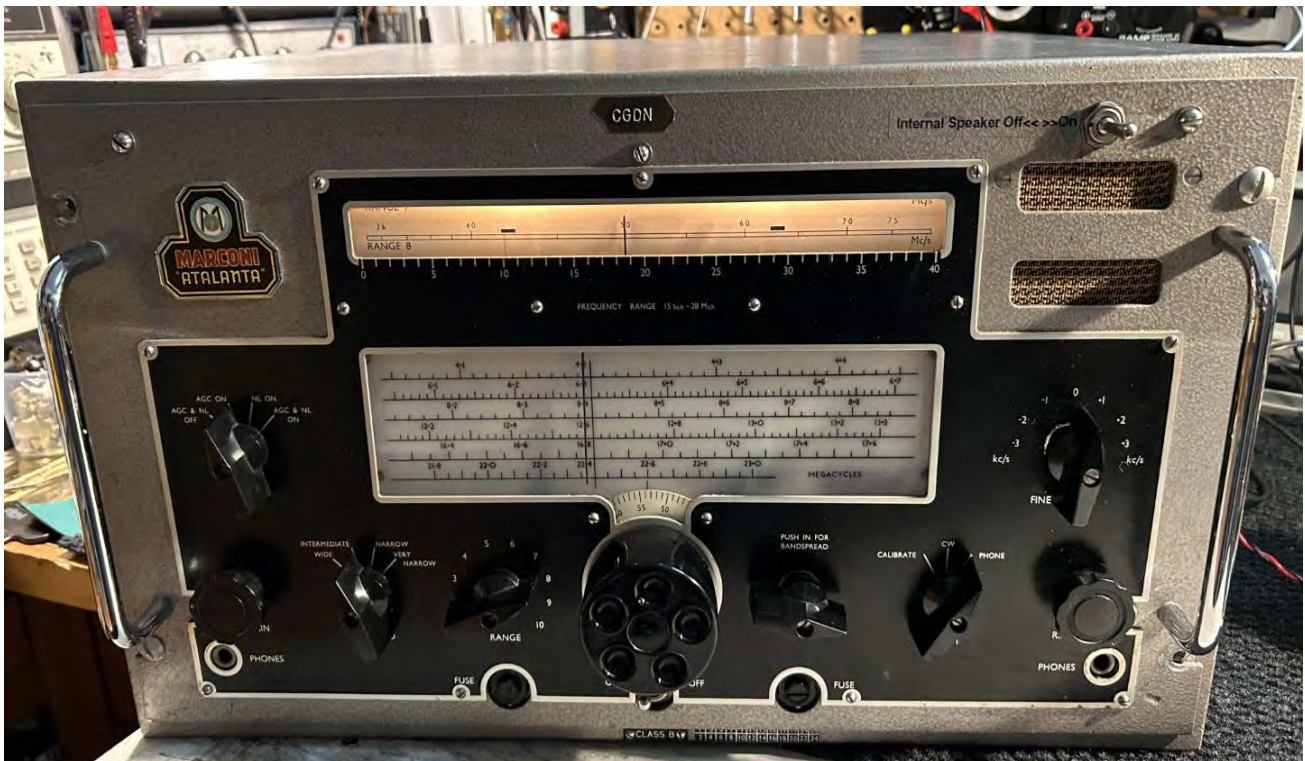
Below: the Atalanta undergoing final soak testing prior to returning to its owner

With the chassis re-installed in the cabinet, I left the receiver on soak test for a day, occasionally changing bands and operating various controls – no issues were noted. The following morning, after a warm-up drift check (very little drift noted after the first half hour), I carried out semi-qualitative sensitivity checks on AM and CW at the bottom, middle and top of each band. These were all undertaken with the 'Narrow' (1KHz bandwidth) selectivity setting – see table, right.

In summary, the receiver was performing very well on all bands with very good sensitivity, and generally well balanced between and across all bands. I noted that even with the chassis installed in the cabinet, some RFI was noticeable on the VLF bands that likely degraded the apparent sensitivity figures slightly on these bands.

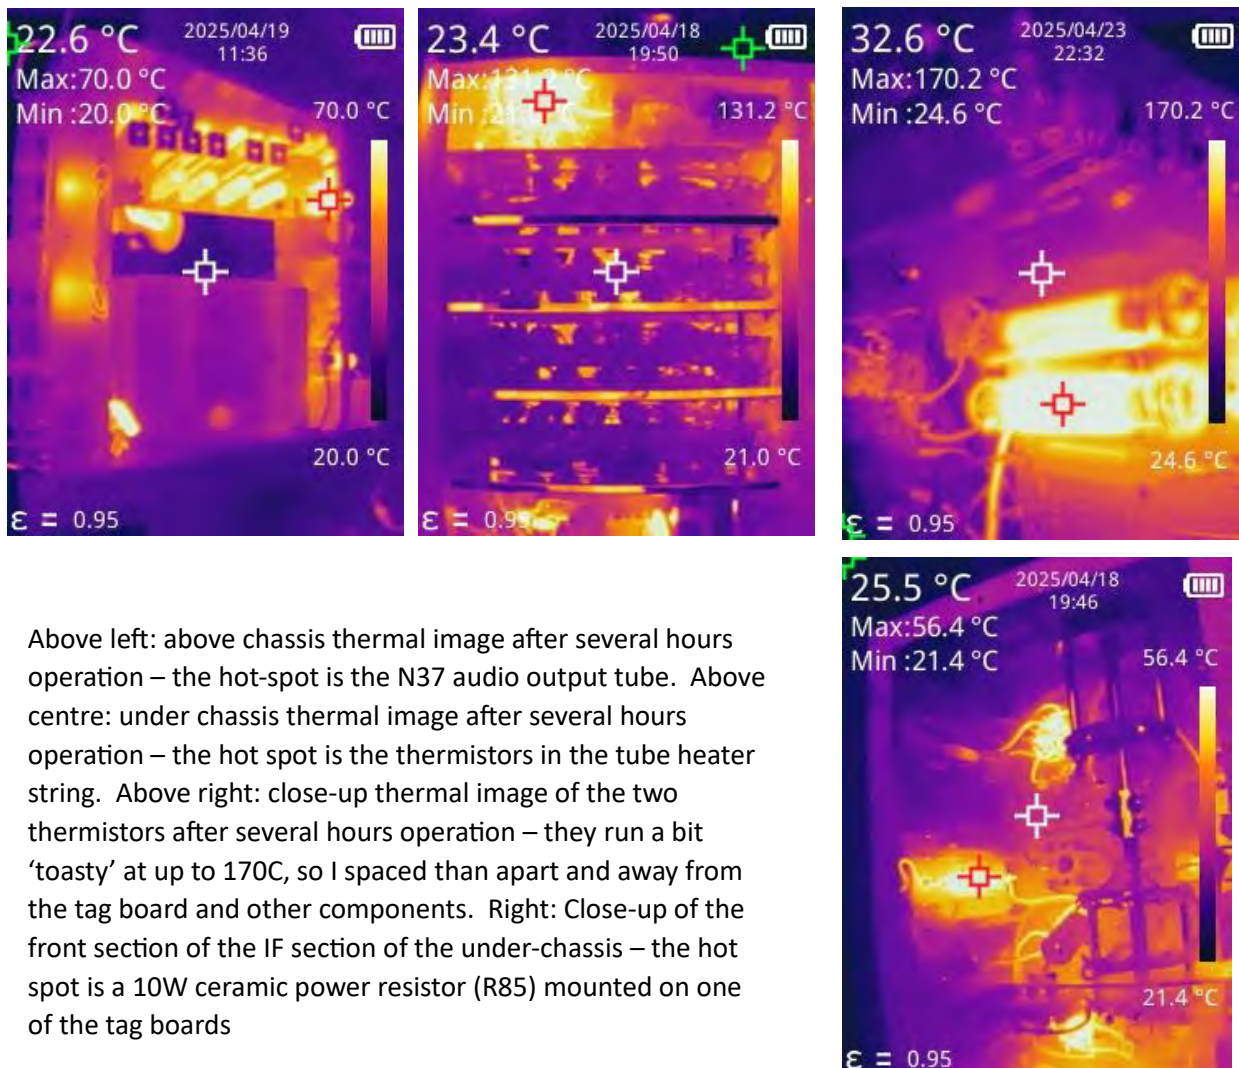
Above left: above chassis thermal image after several hours operation – the hot-spot is the N37 audio output tube. Above centre: under chassis thermal image after several hours operation – the hot spot is the thermistors in the tube heater string. Above right: close-up thermal image of the two thermistors after several hours operation – they run a bit 'toasty' at up to 170C, so I spaced them apart and away from the tag board and other components. Right: Close-up of the front section of the IF section of the under-chassis – the hot spot is a 10W ceramic power resistor (R85) mounted on one of the tag boards

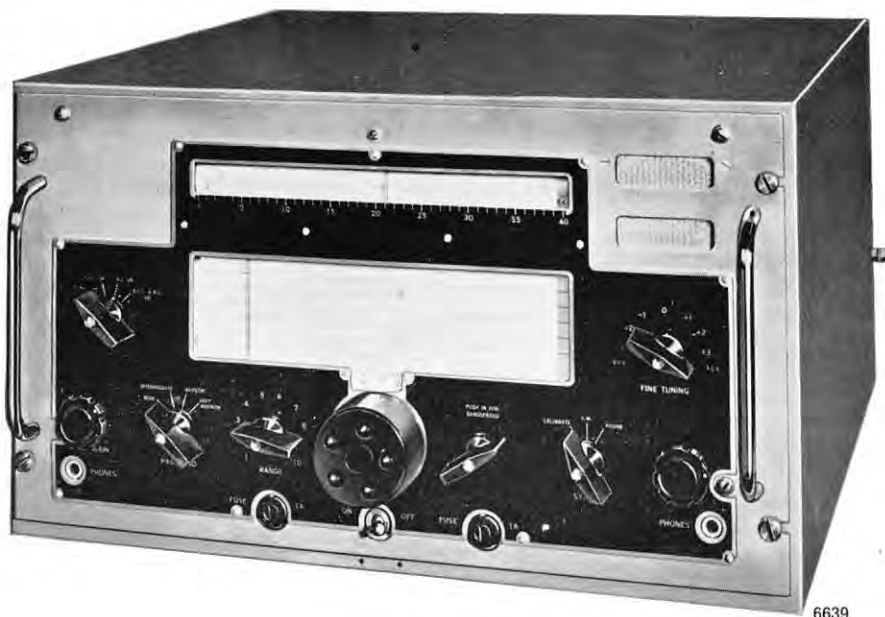
The Type NS 702 has two stages of signal frequency amplification preceding the triode-heptode frequency changer. Two stages of intermediate frequency amplification at 85 kHz follow the frequency changer when signals in the bands 15–25 and 100–800 kHz are being received. When operating on frequencies above 800 kHz, however, and also in the band 25–100 kHz, the double superheterodyne principle is followed in order to secure the maximum image frequency protection. The frequency changer then gives a first i.f. of 700 kHz and an i.f. filter tuned to this frequency is switched into use. This is followed by a further triode-heptode frequency changer, giving a second i.f. of 85 kHz, and two stages of amplification at that frequency. The final i.f. tuned circuit is followed by a double-diode valve which functions as a balanced demodulator on c.w. reception; one diode only is used on m.c.w. Two stages of a.f. amplification are followed by an output stage.

An internal 700 kHz crystal oscillator is provided for setting up the band-spread scale and for frequency checking purposes.
