## Refurbishment of Two Sophisticated WWII Era Tuned Radio Frequency, Very Low Frequency Receivers (Part 1) – Gerry O’Hara

A friend asked me to refurbish two very low frequency (VLF) receivers: a Marconi B29<sup>1</sup> and an RCA TE-236-B. These are both sophisticated tuned radio frequency (TRF) sets dating from the early-1940’s<sup>2</sup>, and although sharing the same basic topology as TRF sets from the 1920’s, their standard of construction and performance is in a different league. **Part I of this article covers the B29 and Part 2 the TE-236-B.**

### Marconi B29

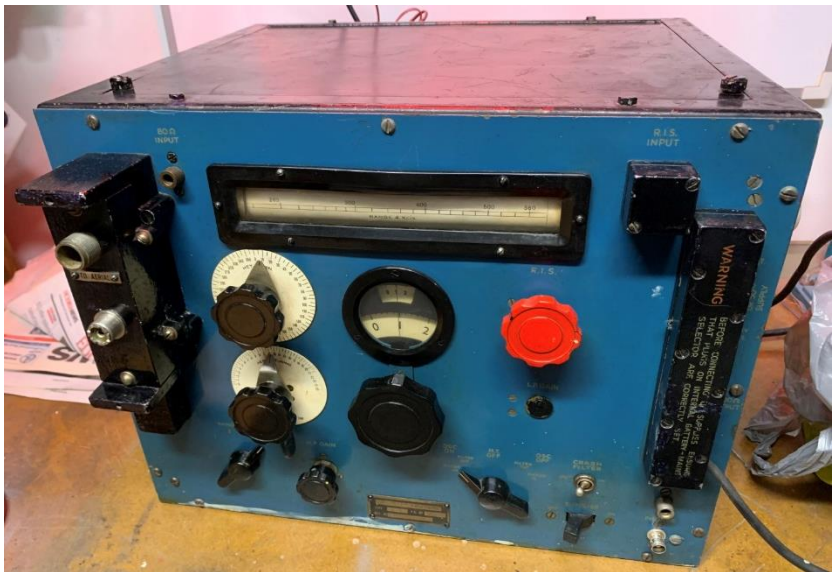
This set (photo, right) is really 'bomb proof' - constructed from heavy-gauge cadmium plated steel with lots of 'iron' (transformers and chokes) - I really struggled to turn it over on the bench.

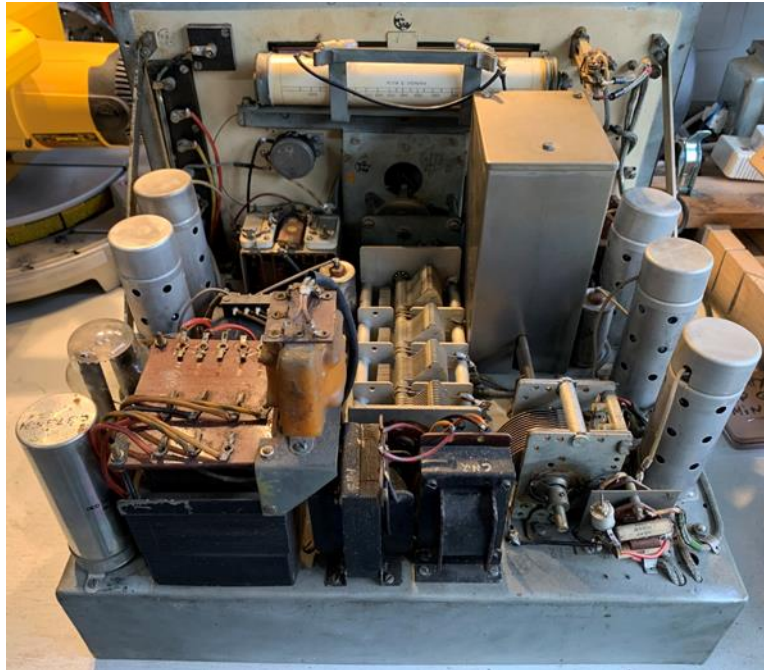
Although being kept in a tight-fitting steel cabinet, the chassis (photo at top of page 2) was quite grubby and corrosion was present on several components, especially the metal-clad capacitor cases. Other than that, the chassis was in reasonable shape and the chassis looked complete. The construction style is interesting, with several unusual controls operating in novel ways, eg. the 'Input' control, which selects the coupling method to the antenna ('Tune', 'Standby', 'Loop 1' or 'Loop 2'), operates a twin wafer switch mechanism via a neat dual crank system, a radar interference suppression (RIS) control to blank out radar pulse interference, sporting a bright red knob, and a 'Het.

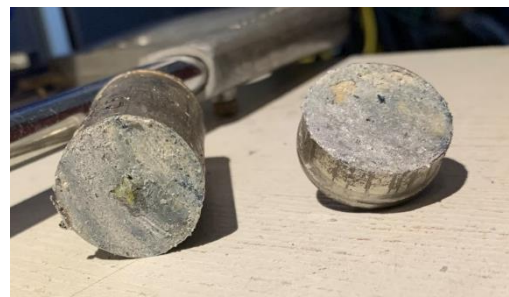
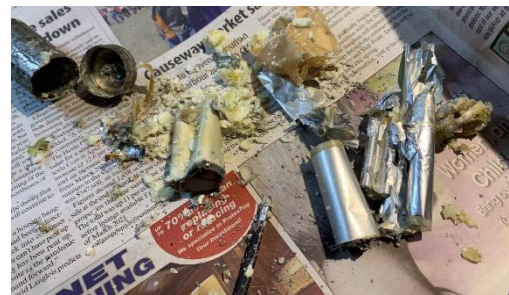
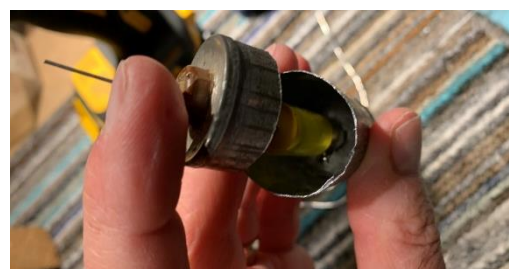
I removed one of the metal-clad 1uF capacitors, and cut into the case with a hacksaw close to the upper end, taking precautions to catch any spilled oil – however, it turned out to be a 'dry electrolytic' type (photo, top right). The innards were a bit difficult to remove, but once they were out (photo, middle right), it was a simple job to restuff it with a new 1uF plastic film part (photo, bottom right): I added a solder lug to the fixing screw (on the inside of the metal capacitor case), and drilled a 1mm hole through the insulated top cap connection. One lead of the new capacitor was soldered to the solder lug (ground end) and the other lead threaded through the 1mm hole and soldered to the insulated top connection. A cardboard sleeve was glued around the inside of the metal case to help join and align the two parts, and a thin band of metal tape wrapped around the join before re-installing the capacitor onto the chassis.

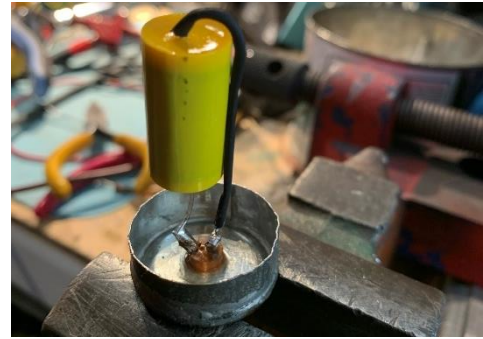
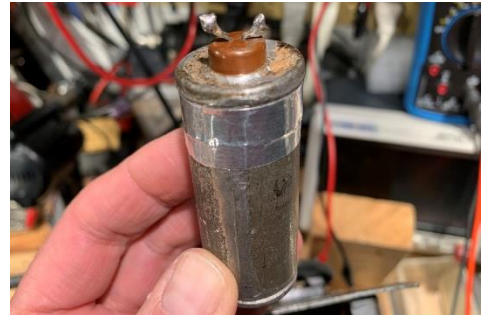
I repeated this exercise for another above-chassis metal clad capacitor – this one was a coupling capacitor in the audio output circuit, not a decoupling one, so the insulated top cap had two solder lugs present where the capacitor leads

were connected to instead of one being connected to a solder lug attached to the case (photos, right). Another chassis mounted metal clad coupling capacitor above the chassis, in the RIS circuit, could not be easily removed for re-stuffing as the nut securing it was located directly beneath part of the band change switch wafer stack and removal of that would have been extremely time consuming and prone to making a switch wiring error on replacement. Instead, I disconnected the original part, sleeved a yellow-bodied capacitor in black heat-shrink and tucked it out of sight behind the RIS potentiometer. This particular capacitor is not present on the schematic, where it is shown as a direct connection – I assumed this was a later modification to improve the RIS circuit which operates by applying a blanking pulse to the two RF amplifier suppressor grids, the level of which is adjustable by the front panel RIS pot. I doubt the owner will use this circuit, but as it may be used on a WWII tugboat that he owns, maybe he will...

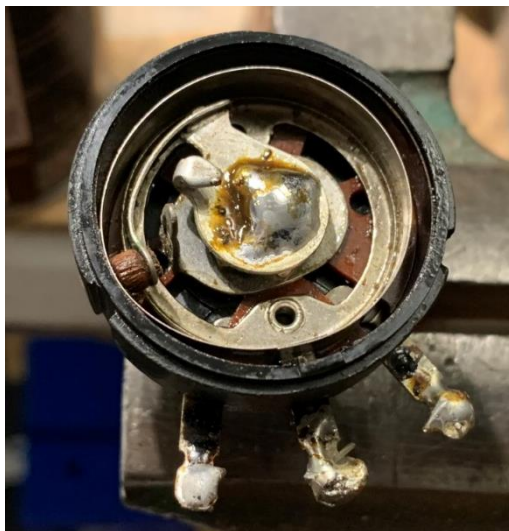
While investigating the RFI circuit arrangement, I found that the pot could be rotated through 360 degrees and the resistance value remained the same(!) – it's a 100Kohm linear taper part. I removed it from the chassis, opened it up, and found that the control shaft had detached from the rotating slider. I cleaned-up the end of the control shaft, applied liquid flux and soldered it with the mighty 'Wall' solder gun (photo, left). I also cleaned the track with Deoxit before reassembling and refitting the pot to the set.

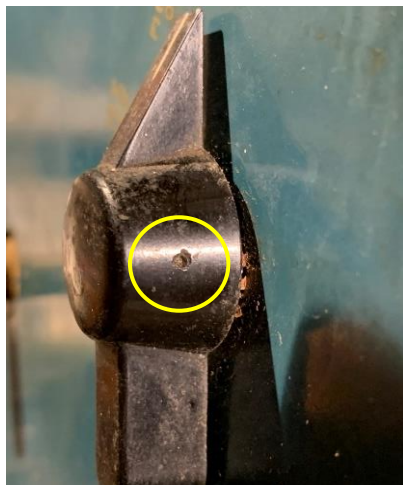
selector lever are held in place by a combination of set screws and small (tapered?) metal pins that pass through the knob and the shaft (circled yellow in the photo, left). These had all seized solid and after a couple of hours I gave up trying, concerned that I would damage the knobs... I have had similar issues with this type of arrangement before, but with larger, tapered pins that had seized, and that allowed a drift or punch to be inserted and the pin knocked out after application of penetrating fluid. These pins are so small that nothing I had in the tool chest would do the job. Options were to:

- persevere trying to remove the knobs/lever, taking more drastic action to remove the pins, risking significant damage to the knobs, ie. attempting to drill the pins out; or
- deliberately destroy the knobs, eg. using a Dremel tool and cutting wheels, and replace these with ones of similar design; or
- leave the pointer as non-functional and tap the BFO signal to feed to a digital frequency meter (DFM), giving the receiver a digital display - this would be 1KHz off the tuned frequency, however this should not be a significant issue in practice.

I discussed the front panel/dial restringing issue with the sets owner. After discussing the options, he thought the DFM readout option would be a good solution if it could be made to work. Also, he noted that he has a machinist friend that he thought may be able to make a suitable drift tool/press to remove the recalcitrant metal pins from the knobs without destroying the knobs in the process – this would best be done when the set is back in the owner's possession. If that is successful, the front panel could then be removed and I would then restring the dial to retain original functionality, but in the meantime the digital readout solution would allow the set to be used. I had also asked around to see if anyone I knew had similar knobs in their junk boxes to replace the originals if I simply cut the knobs up to remove them using a Dremel tool, but no one had, so that option was off the table as the owner wished to retain the original external appearance of the set.

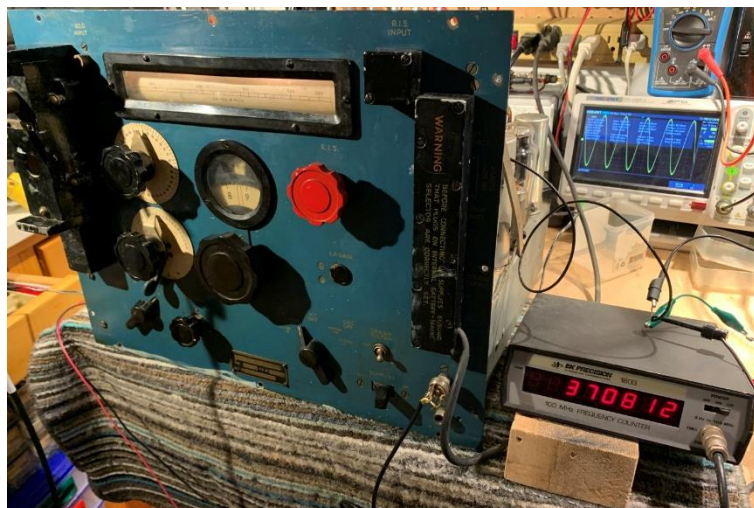
capacitance), but attaching the DFM (an old 1Mohm input impedance BK Precision DFM) stopped the oscillator working at the lower frequencies on each band. So, I persevered in attaching a small (10pF) silver mica capacitor to the tuning gang stator tag and connected this through some miniature coax to the 'scope and the DFM (photo, right). I added a 1Mohm resistor in series with the DFM to provide a little further isolation. I found that the signal at the DFM varied from around 2v p-p

(across the lowest frequency band) to around 200mV p-p at the upper end of the highest frequency band. The BK Precision DFM requires around 60mV p-p to provide a reliable frequency readout and can handle up to 200v p-p, so this was ok. A video showing this setup in operation can be viewed [here](#).

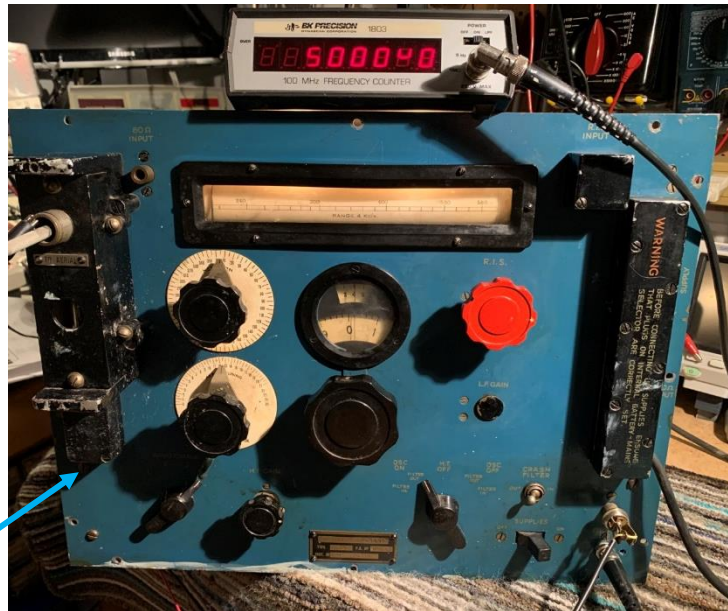
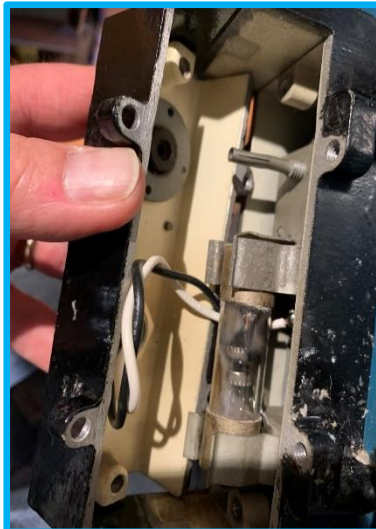
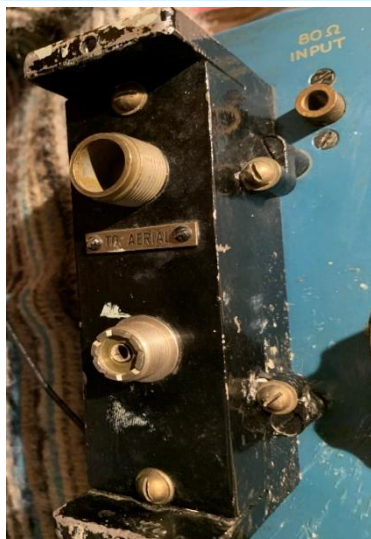
connection. There is provision for four antenna options on this receiver: a low impedance loop ('Loop 1'), a high impedance loop ('Loop 2') – these are both intended for use on the lower two bands when the receiver is installed in a submarine and single-turn loops are used for submerged reception, an 80ohm (balanced) input, using an Admiralty Pattern ('AP') 7151 3-point telephone plug phones-type jack socket, and a 'vertical' (unbalanced) antenna, connecting to the coaxial 'Antenna' connection (AP 1429) located on the front panel gas-gap spark arrestor housing on the left side of the receiver front panel. The 'Input' switch selects how these antennas are coupled to the 1st RF amplifier. Only in the 'Tune' position does the antenna tuning control become effective. I decided that the 'Tune' position of the input switch was the most appropriate for general reception purposes as this would allow the antenna tuning control to be used to peak the signal on a given antenna connected to the coaxial input. However, the AP 1429 connector is not generally available, so I decided to add an SO239 socket to facilitate connection using standard PL259 plugs (or BNC with an adapter). The gas-gap spark arrestor housing on the front panel has an inspection window for the glass gas-gap cartridge and the SO239 socket conveniently fitted this without any modification (photos, left). The SO239 socket was connected to either side of the gas-gap cartridge holder, making for a neat and easily reversible installation.
