Refurbishment of Two Sophisticated WWII Era Tuned Radio Frequency, Very Low Frequency Receivers (Part 2) – Gerry O’Hara

RCA TE-236-B

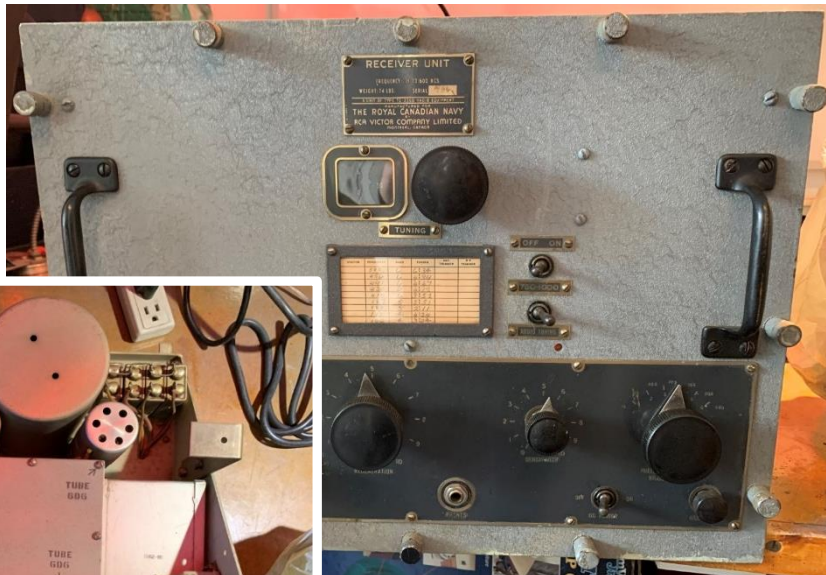
‘An initial ‘once-over’ of the formidable, nay, mighty, RCA TE-236-B (RCA) chassis (photos right and below) showed that its

construction quality is second to none and in a completely different league to the Marconi B29. As far as I can tell, both receivers were designed to do very similar jobs, covering the VLF bands from 15KHz through to the lower

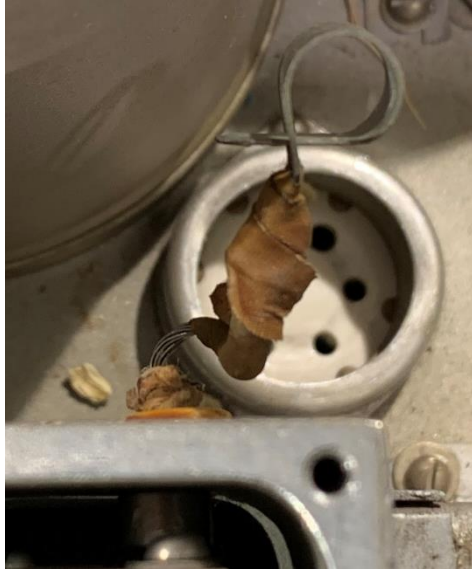
The preliminary inspection of the chassis identified some very minor weeping of oil around some of the capacitor seals – photo, right (which is typical for a 70+ year old parts of this type), and degradation of the rubber insulation on the grid cap wires to the RF amplifier, detector and 1st audio stage tubes (photo, below left). The form of

construction of this set makes replacement of the capacitors problematic: I did not relish gutting and re-stuffing the many paper-in-oil capacitors (around 20 in number), as it is a time-consuming and messy task to cut each one open, and as it is possible they contain PCBs, precautions must be taken accordingly. Instead, I planned on testing several critical ones for leakage and if reasonably low, would

leave them in place for preliminary power-up. Any that show excessive leakage would be replaced externally (leaving the old capacitor in place though disconnected from the circuit).

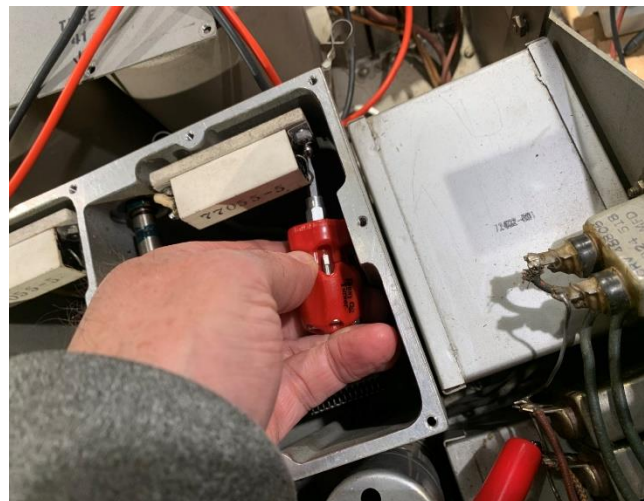
Next, I removed the cover from the tuning gang compartment to access the connections to the two RF tube and detector tube grid wires. Replacing the grid wires that had crumbling insulation was not straightforward for the 2nd RF and detector stages as the connection is made on the underside of a small sub-assembly attached to the inside of the compartment with limited access to the securing screws that must be removed to gain access – very fiddly and needing a very small 'stubby' screwdriver (photo, right). The inside of this compartment

revealed the worm gear drive part of the tuning mechanism: the elongated worm gear on the tuning control shaft engages with a very large scalloped (concave face) helical gear mounted on the tuning gang shaft. A truly massively over-engineered construction designed for minimal backlash.

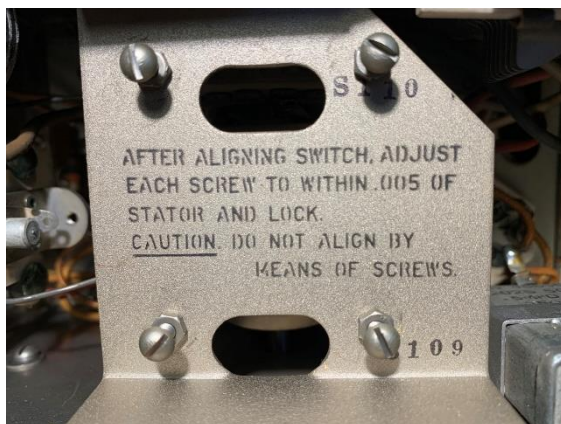
I decided to clean all the controls and switches as a first step in troubleshooting and then check resistor values. This entailed removal of the band change switch compartment cover from the base of the chassis. This revealed one of the strangest band change switch arrangements I have ever seen in a radio – both unusual in design/construction, and massively constructed (of course!). Like the tuning drive mechanism, the mechanical drive parts of the band change switch are over-engineered, comprising a couple of large bevel gears (photo, right) used to turn the switch action through 90 degrees, combined with a large indented metal wheel that engages with a spring-loaded pin so that the slot locations define each band as the front panel band change switch is

rotated. The switch shaft extends across the full width of the radio parallel to the front panel, passing through a total of seven large ceramic switch wafers. The upper edge of these wafers are secured in place with spring clips attached to the chassis, and the lower edge is positioned using adjustable screws and locknuts attached to plates located under the switch. Instructions on how to adjust these screws is printed on the plates – adjustment being to within 5 thousands of an inch(!) – photo, left. Why this arrangement was adopted is not clear, though I

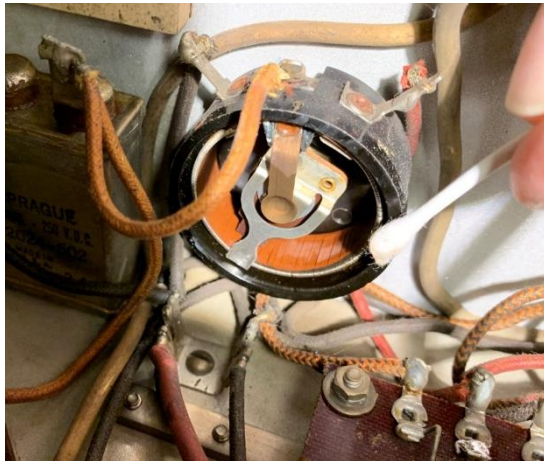
resistors were checked - around two-thirds were out of tolerance and were replaced - photo, right.

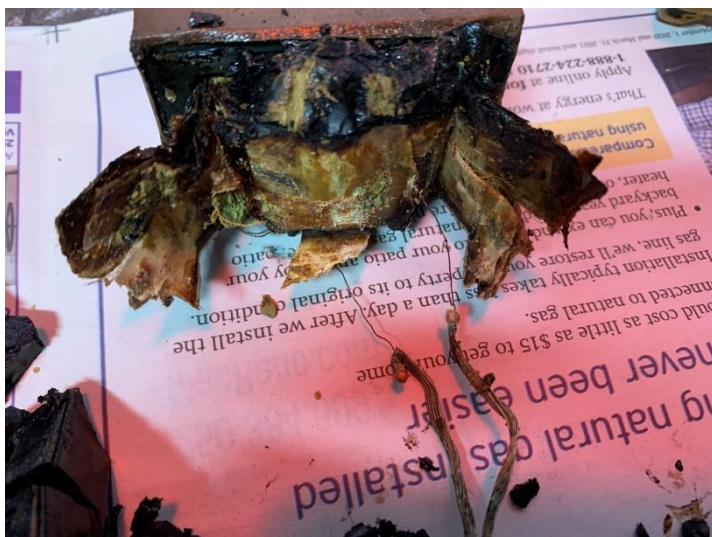
connection points can be the source of open-circuits over time due to corrosion, a dry joint and/or fatigue. Unfortunately, these connections were intact (photo, left), so the open circuit was buried within the winding, and therefore much more difficult to deal with. Instead, I decided to replace the choke – but what with? (and what purpose does it serve? - most sets do not include such a part in the RF gain control circuits). The circuit description in the manual for the similar RCA RAK-7 set does not identify the purpose of this choke, however, the parts list identifies its function as "Choke used as Filter in Cathode Bias

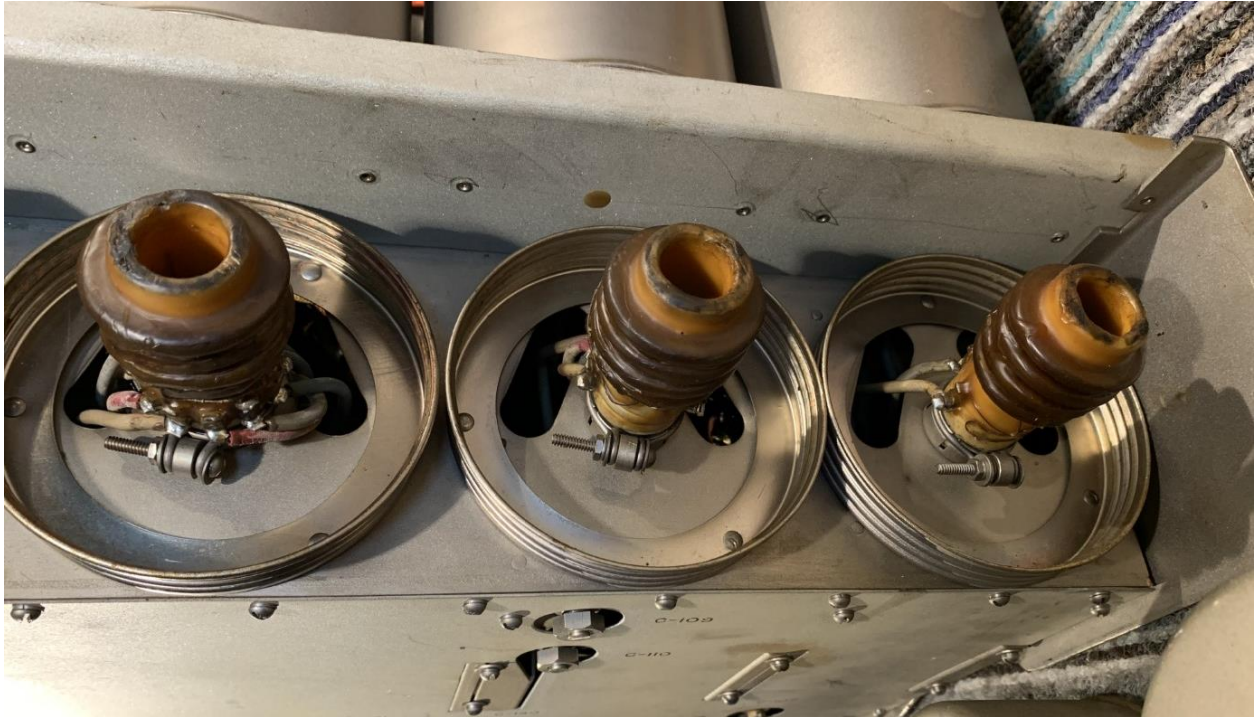
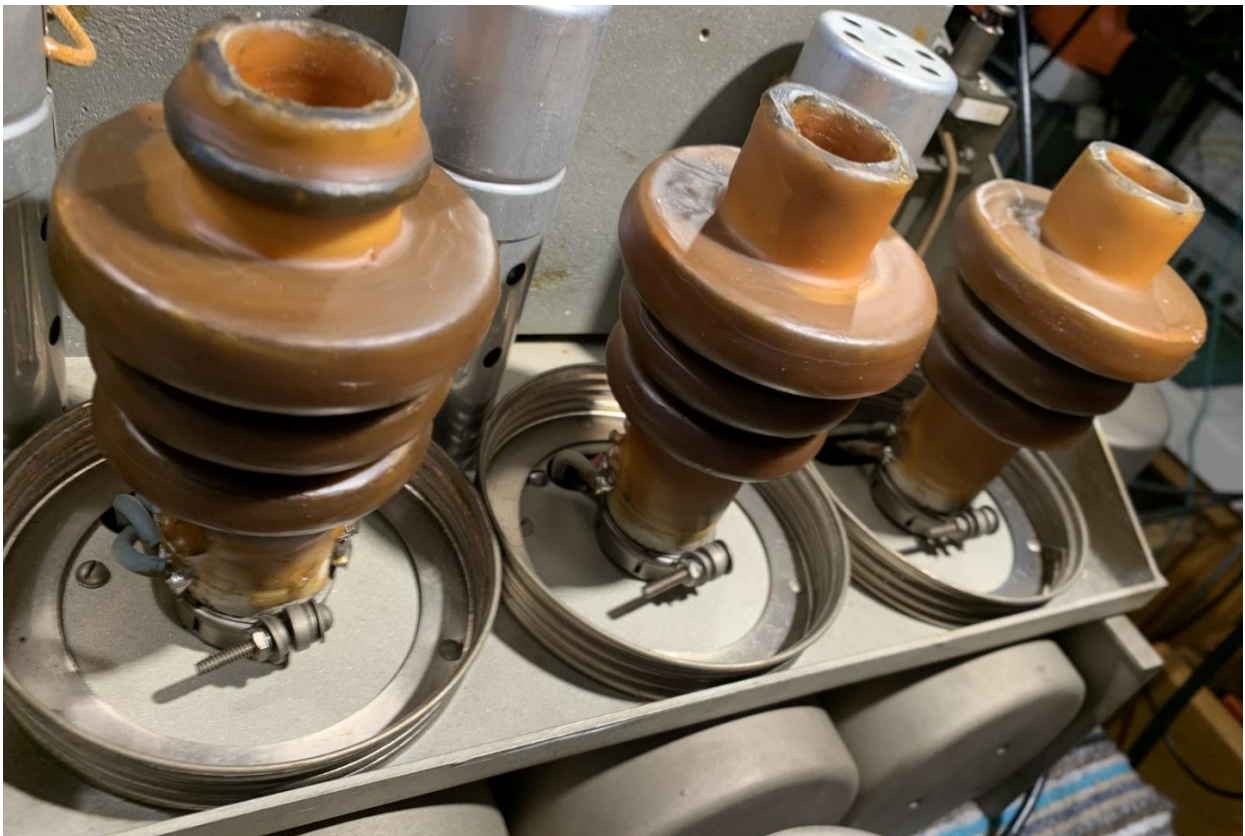
Above: left to right – the TE-236-B detector, 2nd RF and 1st RF tuned circuit coils for Bands 4, 5 and 6.
Below: left to right - the TE-236-B detector, 2nd RF and 1st RF tuned circuit coils for Bands 1, 2 and 3 (these are physically huge for receiver coils!).

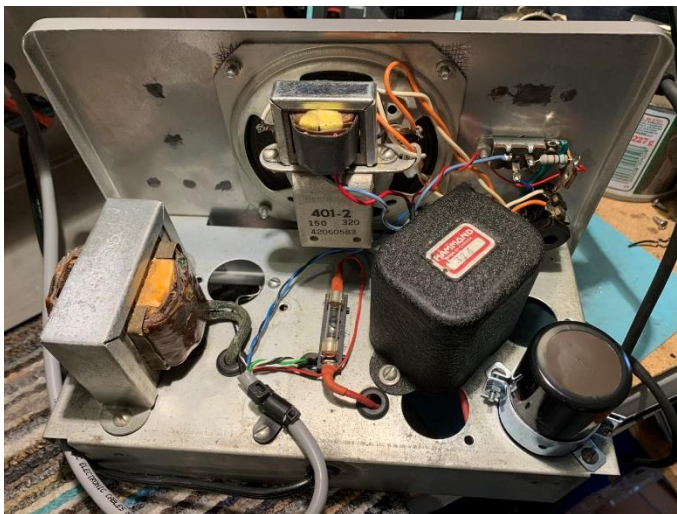
comprising a twin 32uF can capacitor and a 10H choke (the photo, left, shows the above-chassis view of the completed power supply). As the case included a speaker (3 ohm), I included the wiring for it in the umbilical cable between the power supply and the receiver, however it is a severe mismatch to the receiver's 600 ohm line output circuit and would 'kill' the output when connected directly without a matching transformer. I was going to try the output transformer that was in the Heathkit signal tracer unit, but its primary was open circuit - typical. I found a Hammond 262F6 power transformer in my junk box that was (almost) correct for this supply design: 130vAC @140mA plate and 6.3vAC @1.5A heater - this is a bit lower heater amperage than needed by the receiver (6.3v @ 1.8A), but I tested it for a few hours on the 1.8A load and the transformer temperature was barely warm (37C) and the voltage under this load was just over 6vAC. The HT current draw from the set is only around 40mA, so that is well-within the capabilities of the transformer. On operating the receiver, I found that the voltages at

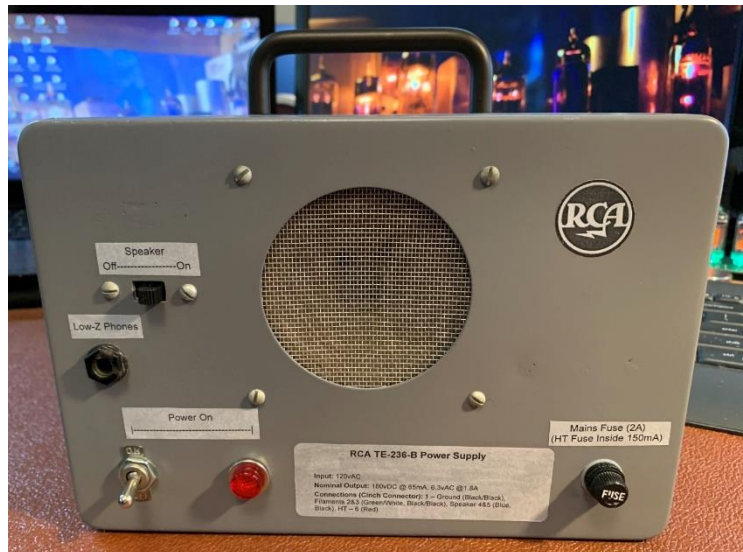
Next, I installed a slide switch on the power supply front panel to select the speaker or dummy load, to allow for when high impedance 'phones are plugged into the receiver front panel 'phones jack socket and a speaker is not needed - I used a 680 ohm dummy load resistor to approx. match the output impedance of the receiver. I also installed a switched $\frac{1}{4}$ " jack socket on the front panel of the power supply to allow low impedance 'phones to be used (when phones are plugged in to this socket it disconnects the speaker automatically). I found a suitable (black) metal handle for the top of the power supply case - looks the part (photo, above).
