Marconi CM-11 Transmitter/Receiver Check-over, Testing and Refurbishment – Gerry O’Hara

Background

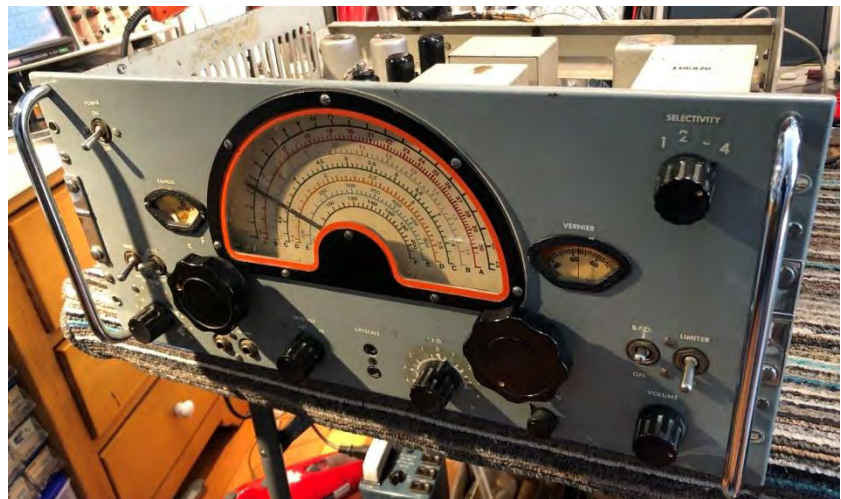
- the receiver had been recapped (all but two tubular paper capacitors and all electrolytics replaced), plus a couple of resistors replaced;
- it appeared that high-quality replacement components had been used, eg. Nichicon electrolytics;

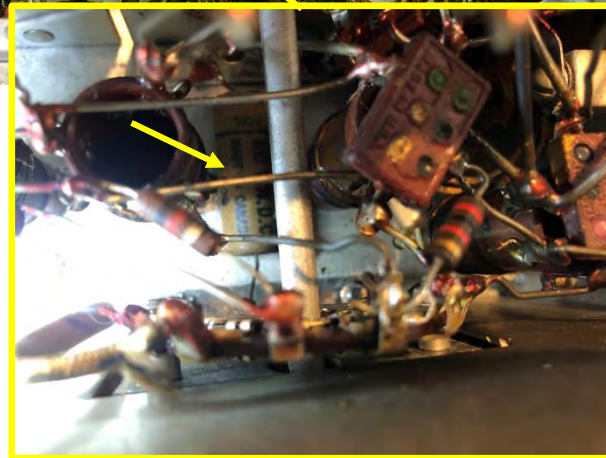
- two of the original tubular paper capacitors remained in place: these were the two 'primary shorting' capacitors in the RF amplifier stages (C19 and C32)² which short out the unused Band coil sections to ground. These two capacitors are very difficult to see, and even more difficult to replace, as they are buried deep in the RF amplifier

compartments (photos, above/right – the arrow on the insert enlargement points to one of these capacitors). They did, however, replace all the tubular paper capacitors hidden under and behind the various tagstrips. I decided to test the two remaining paper capacitors and attempt replacement if needed;

After testing the leakage on C19 and C32, ($\sim 10\mu\text{A}$ at 300v - not enough to cause problems, but probably better replaced), I decided to change-out these remaining two paper capacitors that someone either did not find when they did the re-cap, or gave up on replacing due to their inaccessibility. This was bit of a challenge – this job taking almost 2 hours as half of the band change switch shaft had to be withdrawn from the set (luckily there is a coupling on the shaft, otherwise the front panel would have had to be removed), and several bus wires to the coils and band change switch wafers needed to be temporarily removed to gain limited access and then repaired afterwards (photo, right – arrow points to a replaced capacitor).

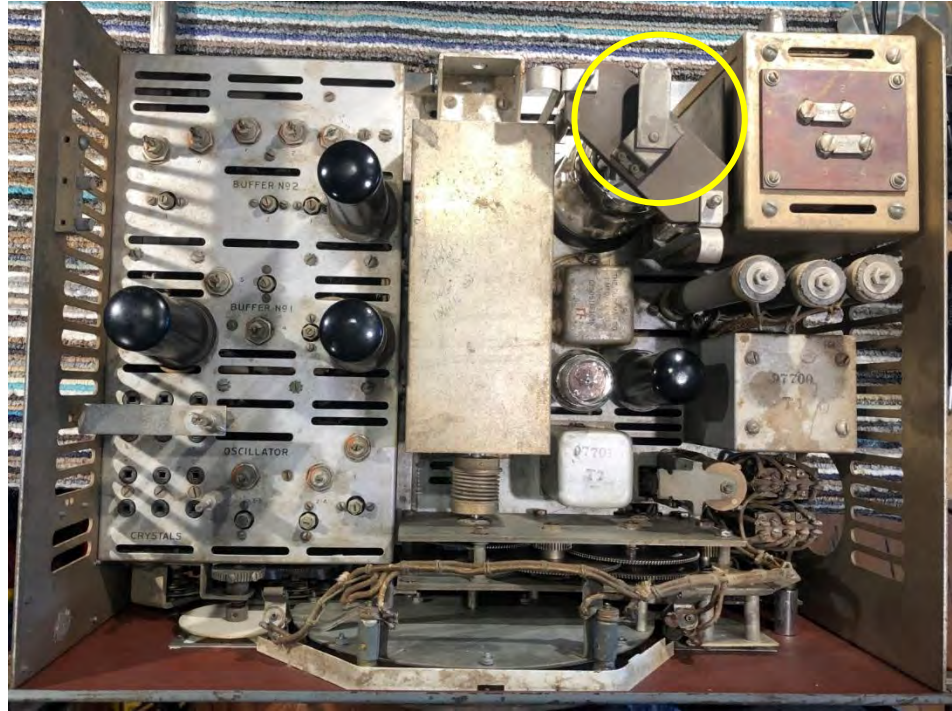
frequency stability³. The plate of the 813 tube is connected by a 'special connector'⁴ to the ATU (circled on photo, right), which includes the 813 tube's plate tuning circuit, variable coupling and antenna tuning circuits. The modulator tube can be switched to oscillate at 1KHz for modulated carrier wave AM Morse code operation (MCW), or used as an audio amplifier to modulate

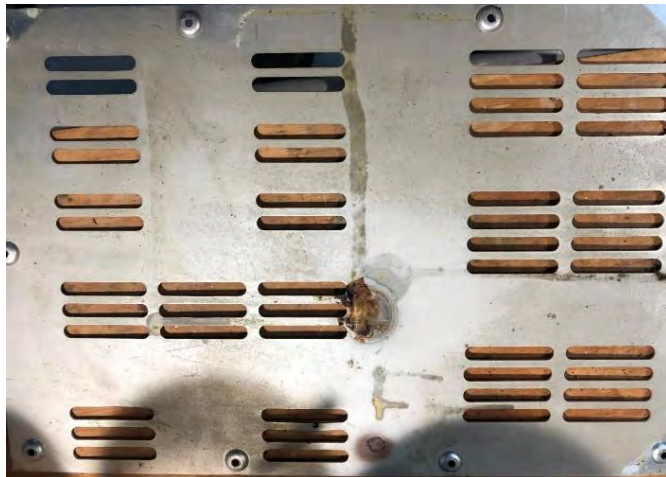
I hauled the transmitter unit onto the bench and undertook some preliminary observations/checks. As for the receiver, it has been largely recapped previously using what appeared to be reasonable quality parts, though the metal 'bathtub' (chassis-mounted paper in oil) capacitors had not been replaced and at least one appeared to have been oozing a little oil from its seals - this could be seen on the inside of the base cover beneath the weeping capacitor (C47) - photo, left. These bathtub capacitors are often ok, even if weeping oil slightly, but can be electrically

leaky also. I decided that these would all be tested and replaced if needed.

- all but one of the bathtub capacitors had measurable leakage current – nothing too serious (several 10's of uA at their working voltages), but this would eventually become worse with time and use. Also, the small replacement electrolytic had been wired across the old capacitor – not good practice. So, I decided to replace them all, using tagstrips mounted on the old capacitor terminals to

mount the replacement capacitors (all 630vV film types), and also re-wired the replacement electrolytic, a high quality 'Nichicon' part, to isolate it completely from the old capacitor (photo, above, which also shows several resistors that were eventually replaced – see 'Troubleshooting' below);

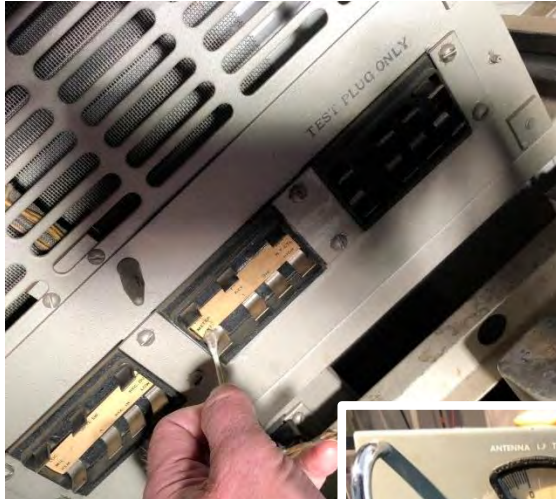
the cabinet wiring to do this with the transmitter pulled part-way out of the cabinet (see 'TEST PLUG ONLY' stencilled above the socket used for this purpose on the photo, left, taken while cleaning the contacts on an adjacent socket with Deoxit), however, the 813 tube plate is still disconnected.

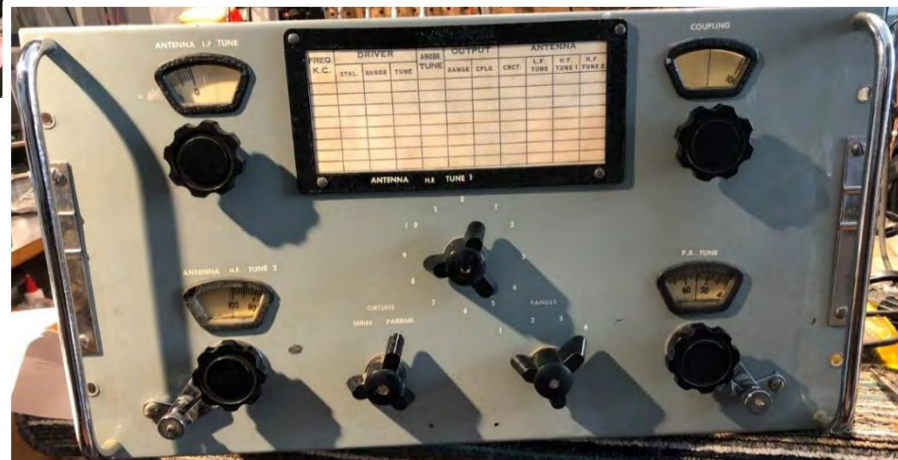
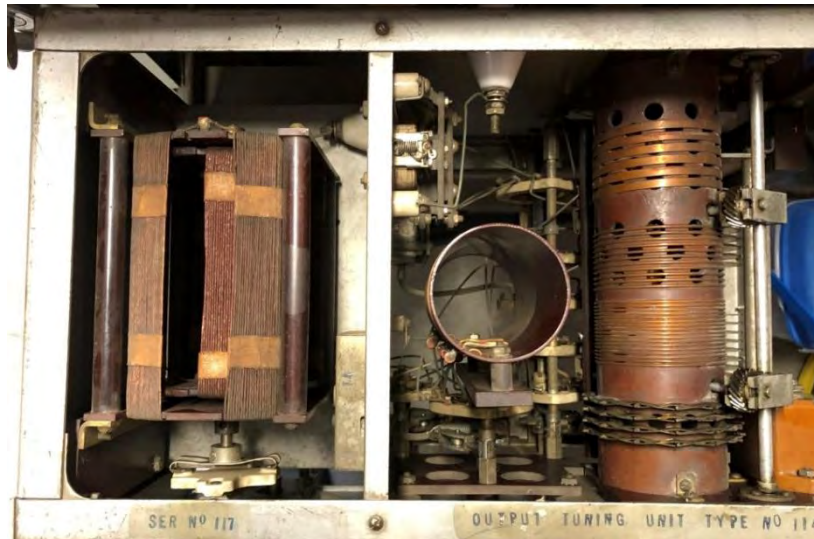
- Some capacitors had been replaced, and, strangely, a new 0.22uF 4Kvw capacitor had been used to replace a 0.005uF 2.5Kvw part (C52) – photo, below. A dual 'bathtub' capacitor was still connected– although this is only in the antenna monitoring circuit, I decided to check its leakage and replace if needed;

- The dual bathtub capacitor was leaking around 80uA on one section and 55uA on the other with 200vDC applied, so I removed it completely and installed two new 0.1uF 630vw plastic film types in its place mounted on a new tagstrip (photo, left);

coils/variable capacitor plates, cleaned all the rotary switch contacts with Deoxit, cleaned and lubricated the variable capacitors, and tightened an insulating coupler that was loose on one of the controls.

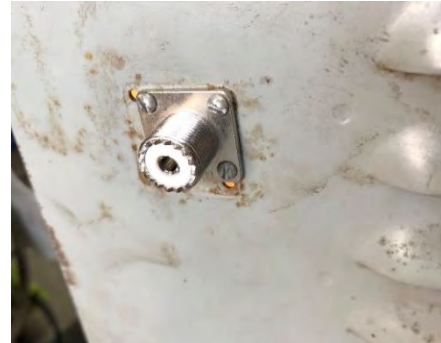
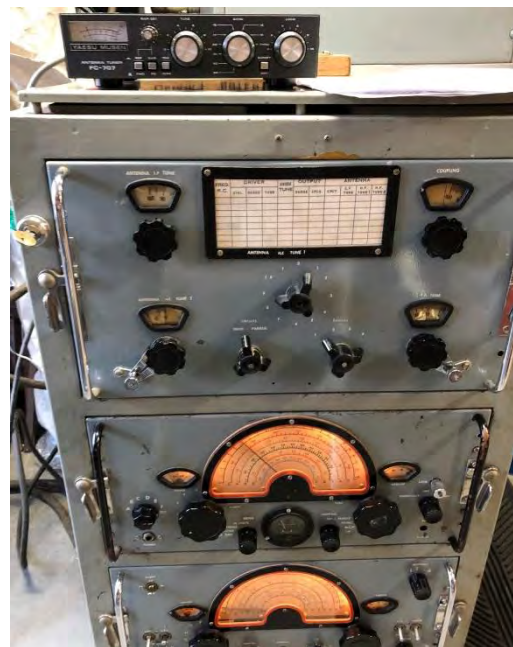
After the 'Man Aloft' key was switched to 'on', the transmitter powered up ok. The receiver was working ok, so its power supply was functioning correctly, was connecting to the antenna (receiving stations), and the antenna relay was switching correctly as far as I could tell. The transmitter also now appeared to be working as it should, but there was hardly any output to the antenna (dummy load) – photo, right: the power amplifier tube (813) was drawing grid and cathode current, and the cathode current could be dipped correctly using the plate tune control on the ATU, however, the

coupling control did not seem to be working⁶. What little power was getting through the ATU to the 50ohm dummy load (estimated around 1W), could be tuned to the dummy load using the LF or HF tune controls. I surmised that the issue could be the coupling goniometer, the 0.22uF 4Kvw capacitor in the ATU, and/or insufficient drive from the transmitter unit (the cathode current draw was less than half what it should be) – see video [here](#) for a demo and explanation of what is happening. Although I had checked the four 1619 tubes and all were strong emission, I had no way of checking the 813 tube, and this could also be part of the low power output problem.

I subsequently removed the ATU from the CM-11 cabinet and changed out the 0.22uF 4Kvw capacitor for two 0.01uF 1600vw capacitors in series, photo, right, giving 0.005uF 3.2Kvw – the same capacitance value as shown in the schematic. I re-tried the CM-11 again, however, this time there was then another issue trying to power-up the transmitter (not the 'Man Aloft' key this time): I heard the HT delay relay click after around 15 seconds, but the remaining dial lights around the transmitter dial did not light up as they should, indicating the transmitter was ready for use. HT was not

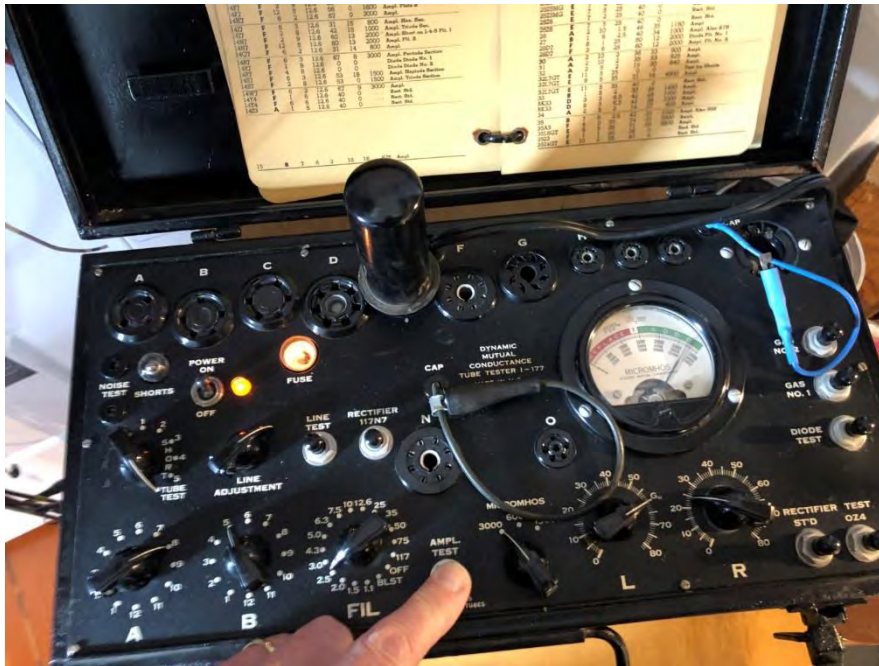
With the CM-11 transmitter back on the bench and the relay contacts burnished, cleaned and tested, and the snatch connectors cleaned, I replaced all resistors that were out of tolerance (even if by only a small amount). I doubted this would make much difference but ended up replacing 7 resistors in total. I also tested the four 1619 tubes in my I-177 tester for mutual conductance (photo, left) and they ranged from

2200umohs to 2700umohs. The spec. for this tube type is 3400 umohs to 4500umohs depending on source of info, so they are 'under par' (assuming the I-177 is producing reasonable readings), however, I doubt not so much as to almost half the drive power to the 813 tube. I had no means of testing the 813 tube, but I removed it, cleaned its pins with Deoxit and examined the internal structure - the tube looked new – but looks can be deceiving. I also cleaned its ceramic socket with IPA before re-installing the tube.

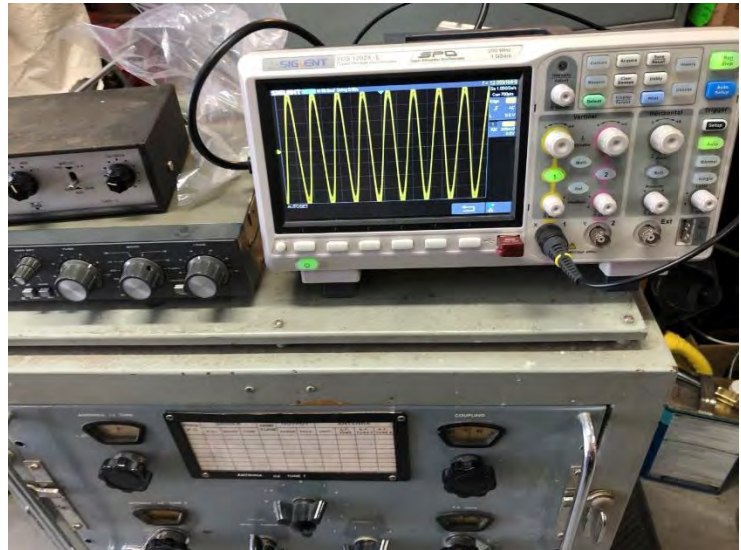
So, I decided to use a 'scope to measure the AC (RF) voltage across the 50ohm dummy load to confirm the output power as being measured on the Vanco SWR/power meter (photo, right). This is a simple technique and is described in a short article, [here](#). There are also several videos on YouTube that describe this technique.

- CW: peak to peak 220v, RMS 76v = 115W (nice clean sine wave output signal as in photo, above)
- MCW: peak to peak 260, RMS 60v = 72W (see text below)
- Phone: peak to peak 120v, RMS 41v = 33W (nice clean output signal, similar to that on 'CW')

The 'scope trace on MCW showed the signal was over 100% modulated (photo, right), and there is no way of adjusting this in the transmitter. Over-modulation can cause harmonics, and I know the CM-11 has a reputation for generating these. Also, the complex waveform on MCW 'confused' the digital 'scope a bit – it was measuring the frequency as 7.8MHz and the peak to peak voltage measured by the 'scope's acquisition circuitry varied significantly, though the reported RMS voltage was steadier. This sort of waveform could certainly affect an analogue meter reading also (as in the Vanco unit). A video of some of the measurements being made using the 'scope can be viewed [here](#).

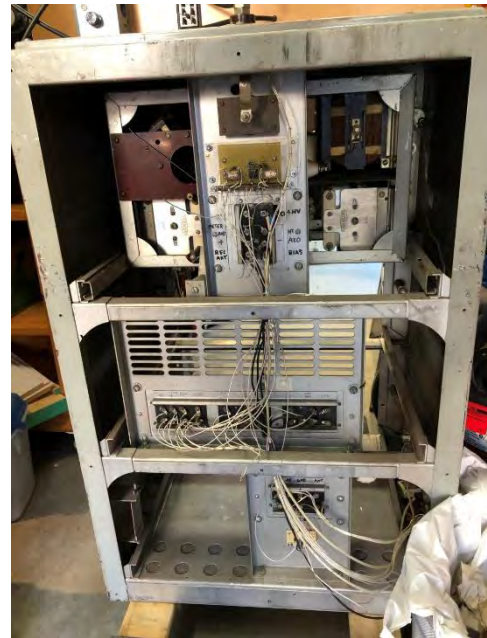
The owner also brought me the remaining parts of his 'spare' CM-11 to work on - I already had the transmitter and ATU from this, and so he brought me a CSR-5 receiver, a second 'spare' transmitter, and the three power supply chassis. The power supply cabinet was not included, and the power supply chassis connect to the CM-11 cabinet via a home-made arrangement built on a piece of chipboard (photo, below).

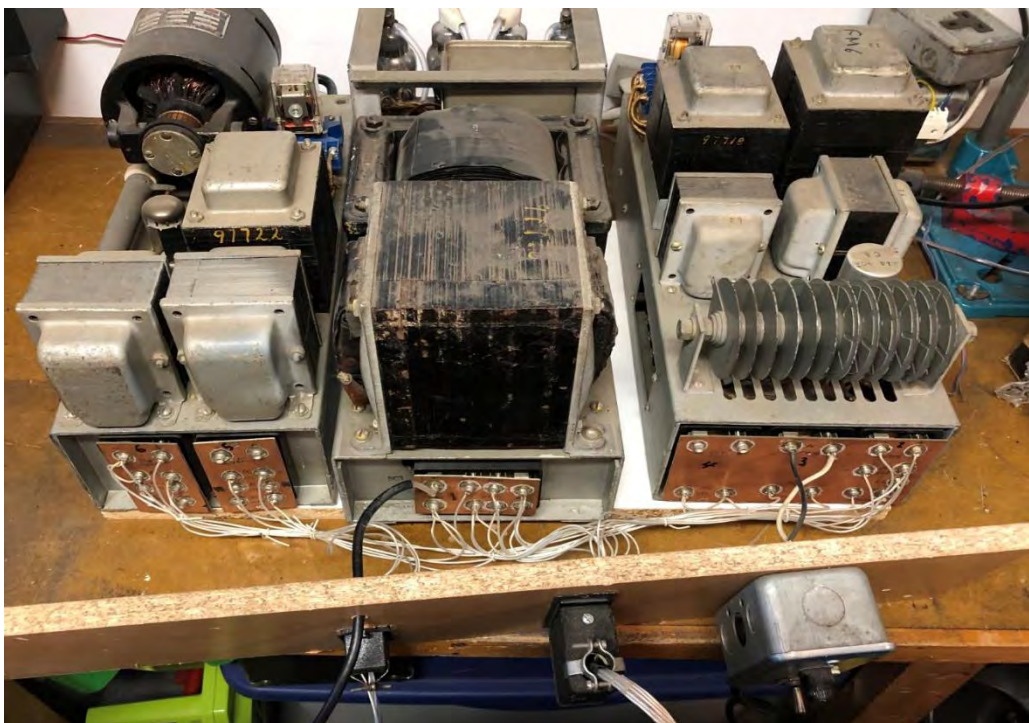
Also, this CM-11 cabinet has been completely butchered, with the phone and remote sockets replaced by jack sockets, all the internal wiring replaced by a festoon of Teflon-coated wiring (photo, above), as well as including some additional miniature relay boards with transistors and IC switching arrangements (why on earth would someone do that?). The power supply chassis have also been modified, with new relays installed, and both transmitters and the CSR-5 receiver have had a few parts replaced, but are in need of a thorough going-over. I intend to take a bit of a 'breather' before I tackle any of these 'spare' units though... so look out for an addendum.
